Dutch Barn Research Miscellany Vol. 1 No. 2, 1988

The TELLER/SCHERMERHORN BARN
Schermerhorn Road, Schonowe,
Rotterdam, SCHENECTADY, N.Y.
1701-1948.

WHAT IS A DUTCH BARN? AN OPINION

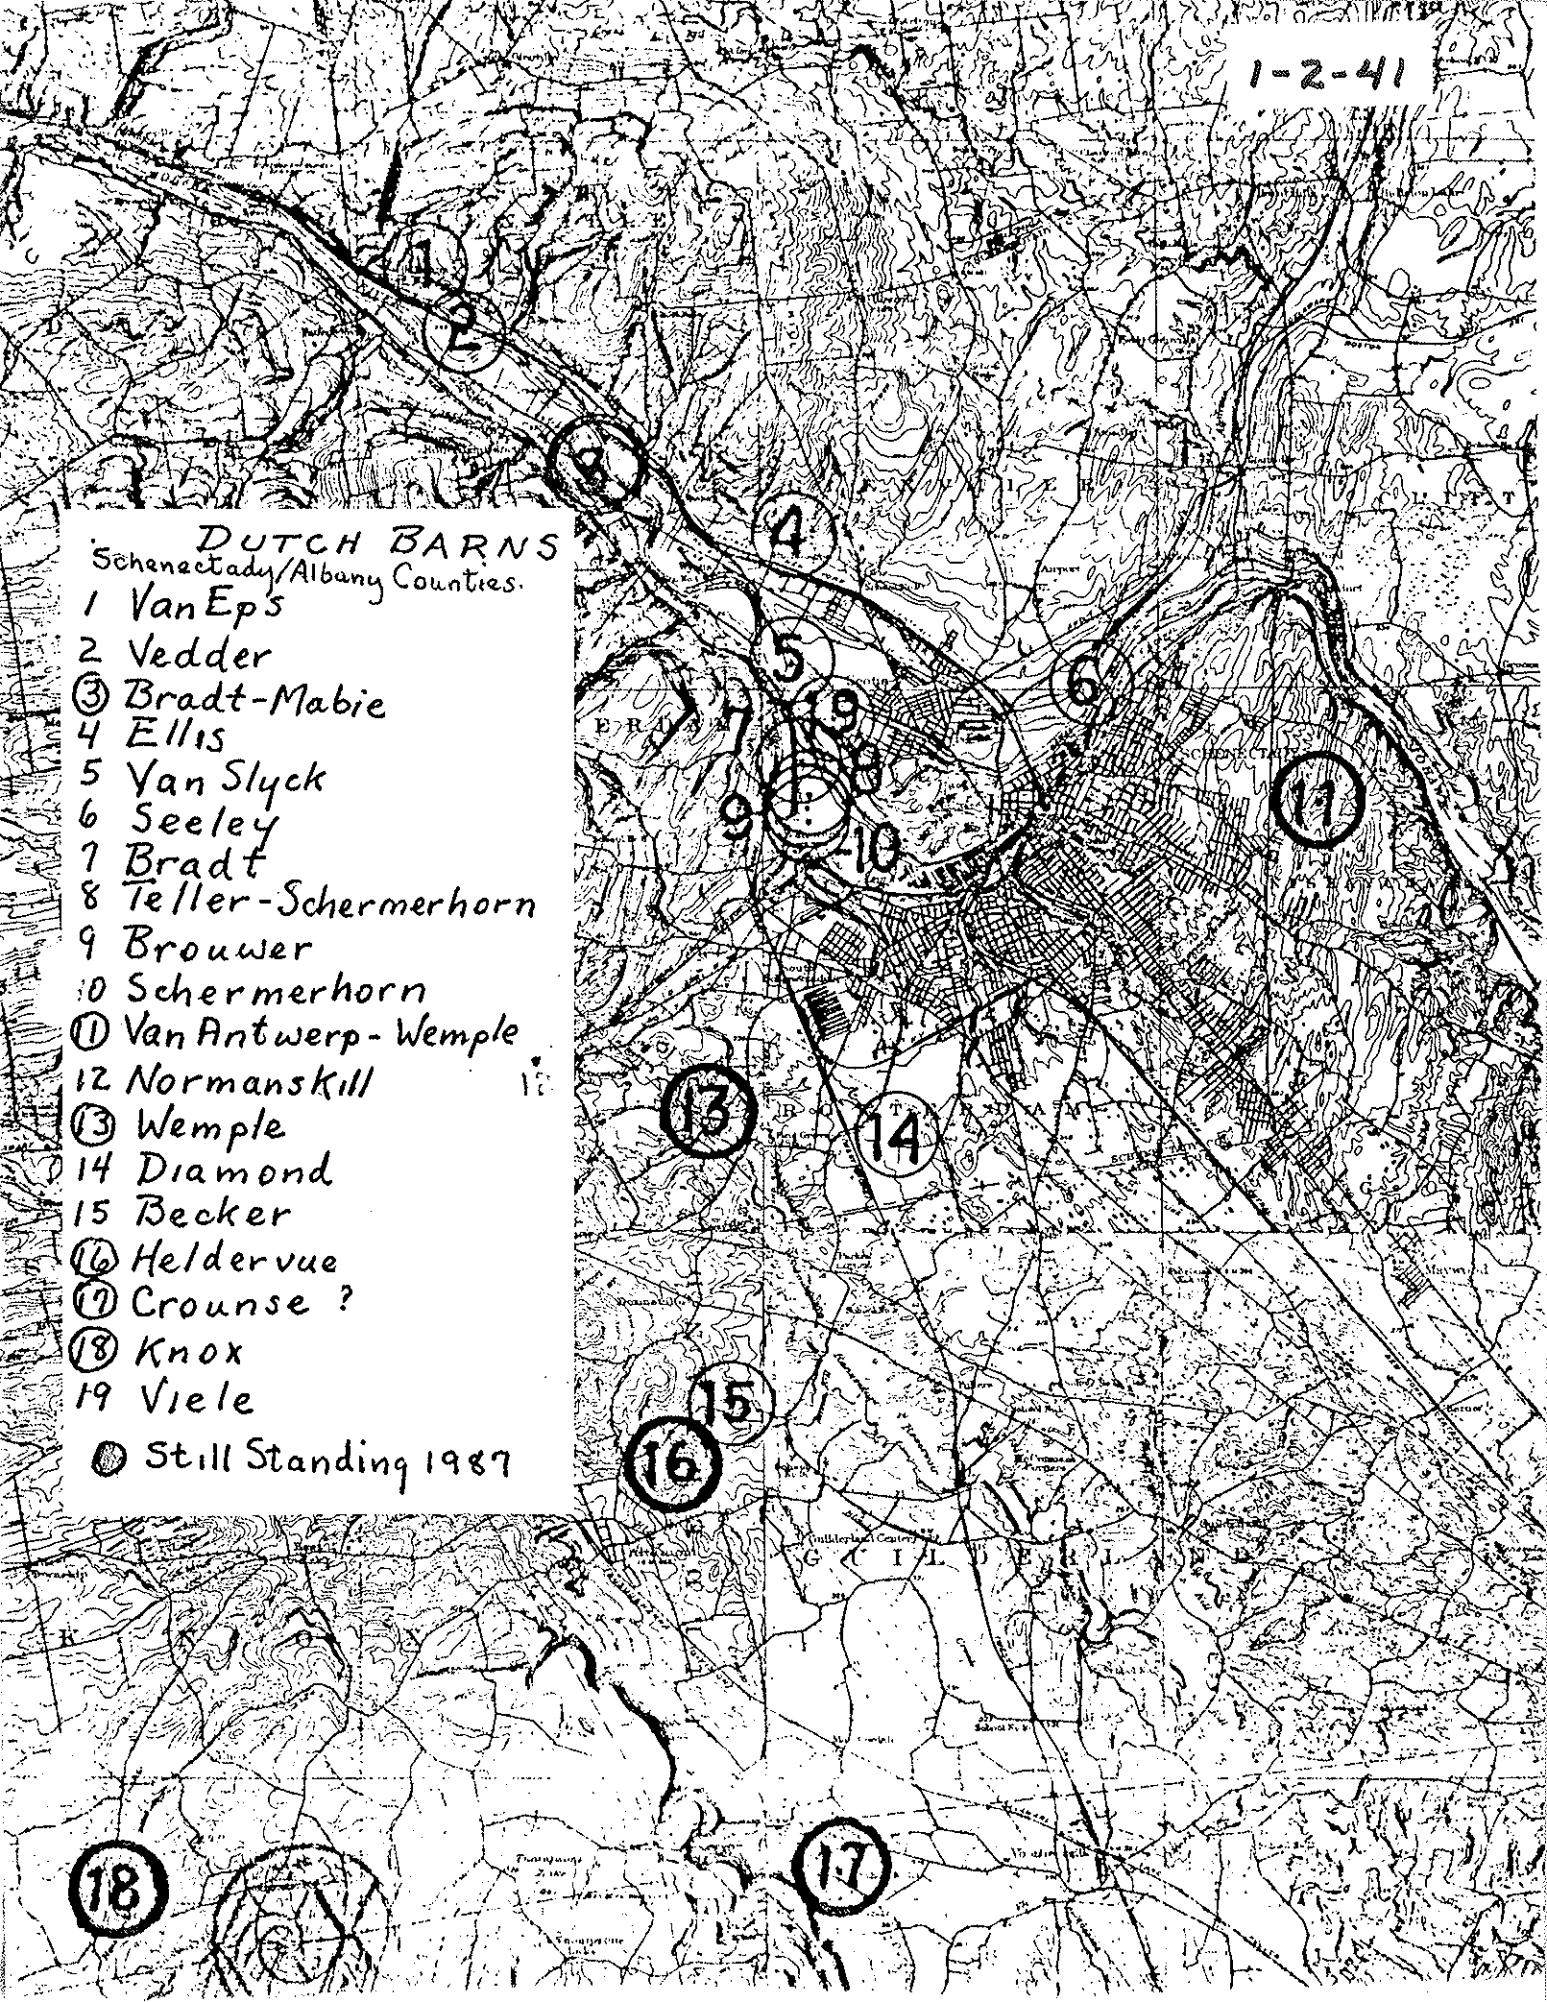
Schenectady/Albany Counties.

- 1 Van Eps
- 2 Vedder
- ③ Bradt-Mabie
- 4 Ellis
- 5 Van Slyck
- 6 Seeley
- 7 Bradt
- 8 Teller-Schermerhorn
- 9 Brouwer
- 10 Schermerhorn
- ① Van Antwerp-Wemple
- 12 Normanskill
- ⑬ Wemple
- 14 Diamond
- 15 Becker
- ⑬ Heldervue
- ⑰ Crouse ?
- ⑱ Knox
- 19 Viele
- Still Standing 1987

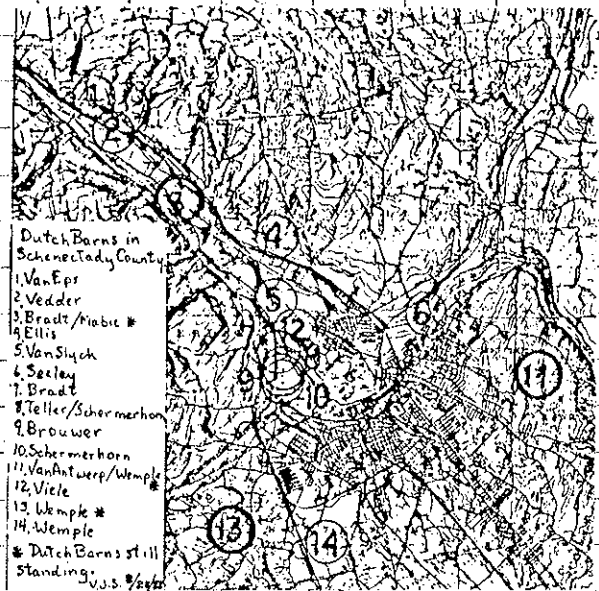
The Dutch Barns of Schenectady County.

I started photographing Dutch Barns more than fifty years ago and will provide brief comments on the 14 of which I am familiar. These on the map were all within Schenectady County.
