# DUTCH BARN PRESERVATION SOCIETY NEWSLETTER

SPRING 2010

## The Tarbox Farm, 1533 Route 7, Brunswick, Rensselaer County, New York

## A Parting Glance at a Stone Arabia Barn

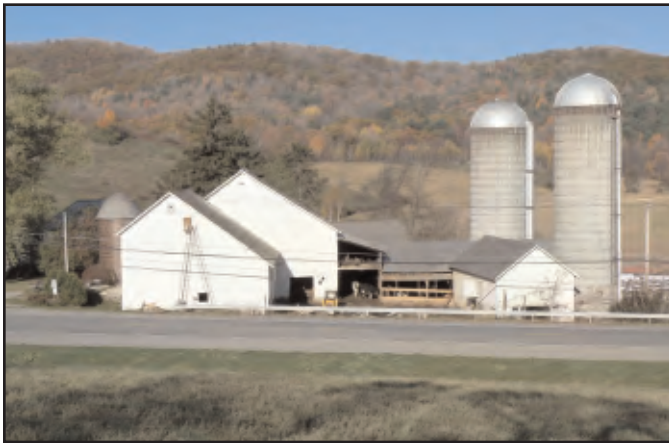
Photo 1. A view of the farm from the south. The four-bay New World Dutch barn is in the center, behind a smaller English Barn. The farmhouse is in the trees to the left; in the center of the barn complex is the barnyard. Behind the silo to the right is another long, low cow barn used for heifers. The silos date to 1916, 1975, and 1977.

One of the most prominent farms in Brunswick, Rensselaer County is the Tarbox Farm, sitting on busy NYS Route 7, between Troy and Pittstown. It is a large complex of structures, housing a dairy and farm stand operation, built over a number of years. Hidden in the center of this complex is a New World Dutch barn; it is hard to spot as you drive by, but once identified, the characteristic shape stands out (Photos 1 and 2). The Dutch Barn Preservation Society toured the barn in June 2009.

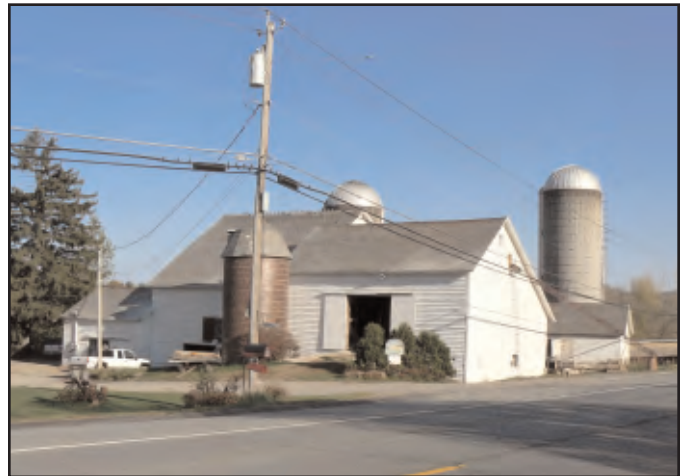
Photo 2. The barns seen from the southwest. The Dutch barn is behind the 1916 tile silo. The barn closest to the road dates to the later nineteenth century.

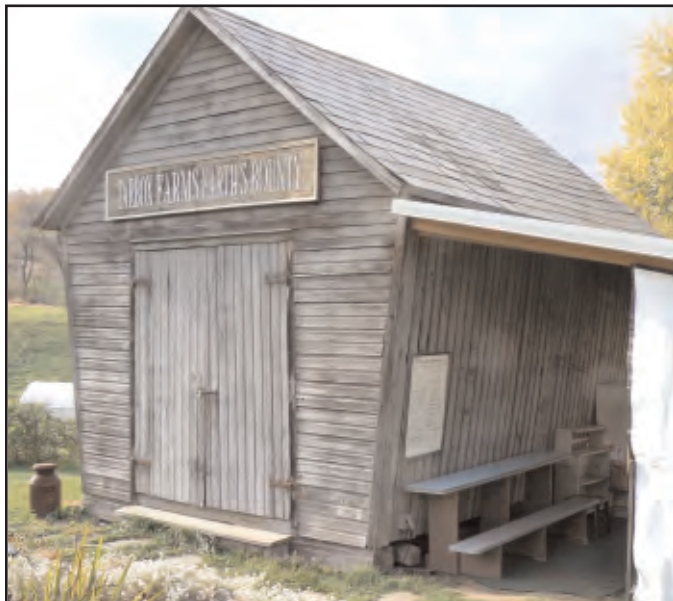
Photo 6. The c. 1830 corn crib.

John's son David now runs the dairy operation. David, a Cornell graduate, lives with his family just west of the main farm. In addition to the milkers they have another 70 cows of young stock. They also have a farm stand operation begun about 10 years ago by John's wife Joanne. Joanne was the Rensselaer County Coordinator for several programs of the Cornell Cooperative Extension. The farm stand is housed in an historic corn crib; a plaque dates it to 1830 (Photo 6). About five acres are kept under cultivation to support the farm

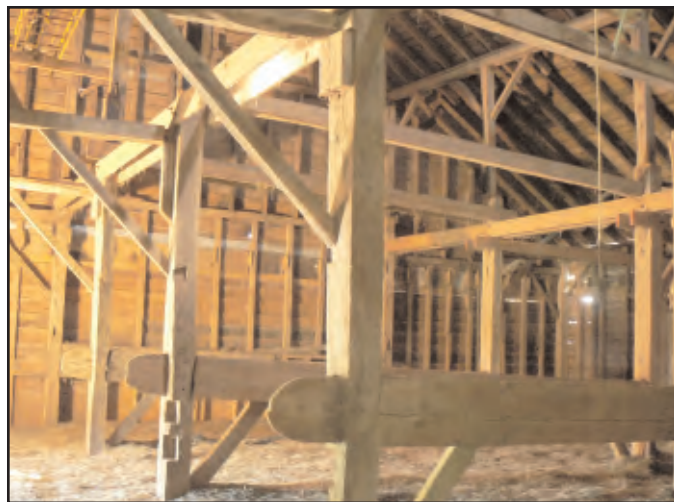
Photo 7. Interior view of barn, showing later framing.

The core of the four-bay scribe rule New World Dutch barn is relatively intact, but the barn has been expanded and remodeled several times. The posts were extended between six and eight feet to make more room for hay storage in the late nineteenth or early twentieth century. Light dimensional lumber was used for this work, and the braces appear to be nailed. Each side has also been added to, again for more storage (Photos 7 and 8, Figure 2). Later modifications strengthened the structure; double sets of 2" by 10" braces and steel angle braces were added probably in the middle decades of the twentieth century.

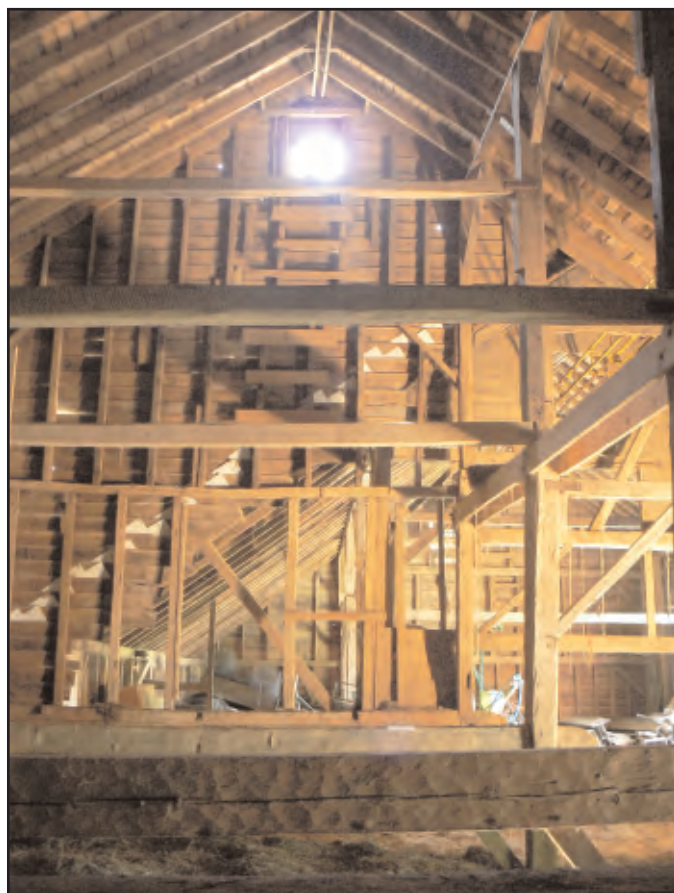
Photo 8. A second interior view.

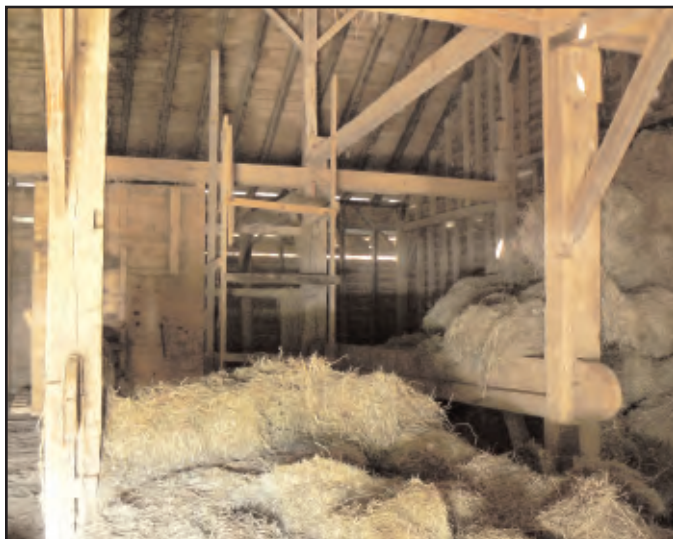
Photo 9. The anchor beams are both pegged and wedged. Unusually, the anchor beam tenons are centered on the posts, as seen in this view. Note the cutouts in the anchor beams, forming a ledge which held the floor of the second level. This detail can also be seen in Photo 10.

There is now a mow floor underneath the anchor beams and cows are housed below. Each anchor beam measures 1'-3 1/2" by 8", with a tenon protruding 1'-1 1/2". The span of the anchor beams, from inside post to inside post, is about 18'-11 1/2". There is evidence of long sway beams on the end bent posts; a mortise 8'-2" down from the top of the post was observed. It is a little difficult to determine the original floor level, as a concrete floor has been poured, but the bottom of the anchor beam is about 10'-8 1/2" from the current floor. From the top of the anchor beam to the base of the original purlin measures 9'-0". The posts are 8 3/4" by 10 1/2". The anchor beam tenons are centered on the post, which is unusual; it is more typical to see them offset toward the layout face.<sup>2</sup> (Photos 9 and 10)

second bay back from the road. There is a cutout in the anchor beams to hold a floor at this point. This detail has been observed in the Herrington's Dutch barn, the Wagner barn (both since taken down) and a third barn, all in Brunswick, and the Stanley Lord barn and one other in Poestenkill.<sup>3</sup> (Photos 9 thru 12, Figure 3)

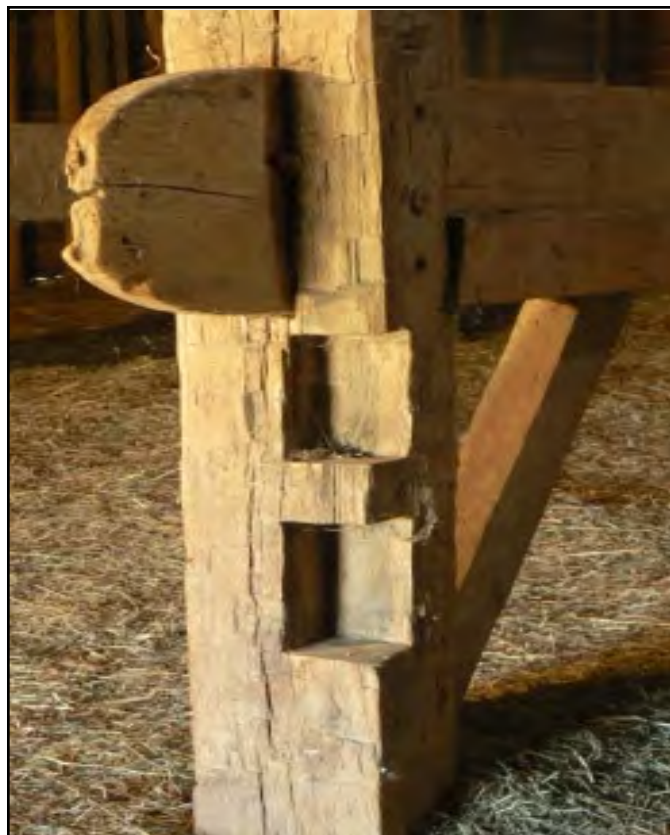
Photo 10. The open mortises cut into the face of the post seen here may have held the supports for the ramp.

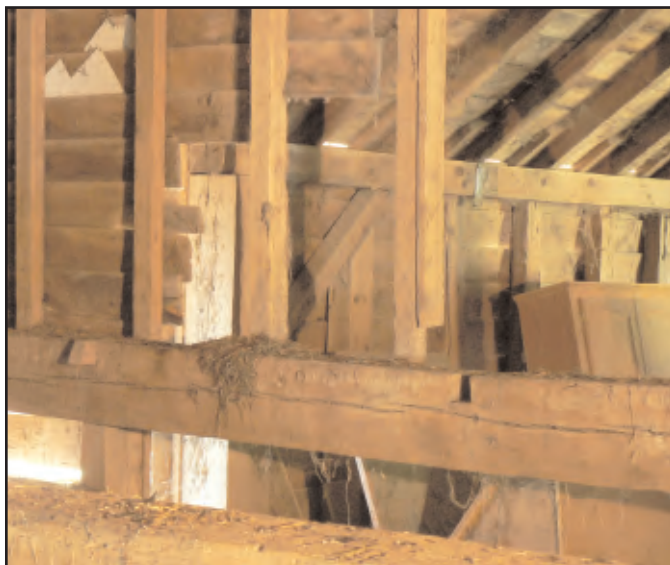
Photo 11. Details of the end anchor beams. At the front end you can see the end of one of the pence support beams is still in place.

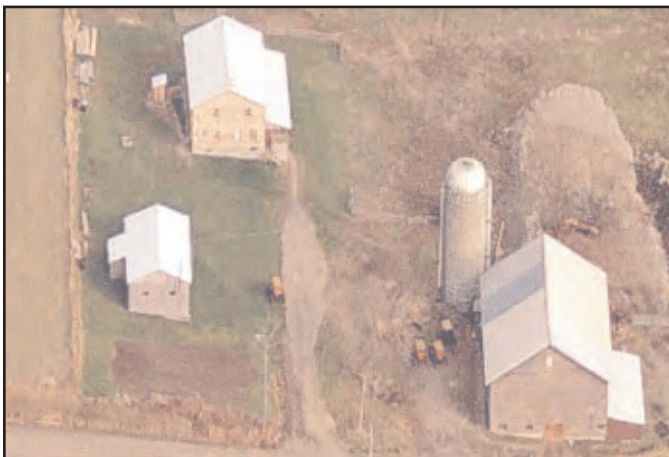
Photo 1. Aerial view looking east of the farmstead before removal of the New World Dutch barn.

the Town of Palatine in Montgomery County, it was on Turn Hill Road which is a few hundred feet into the Fulton County Town of Ephratah (Photos 1 and 2).

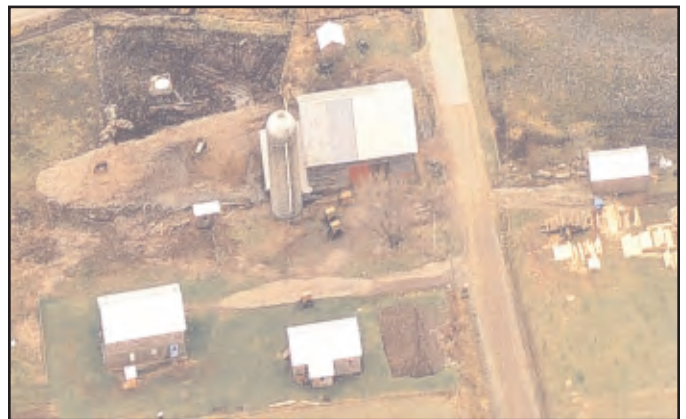
Photo 2. A second aerial view, looking south.

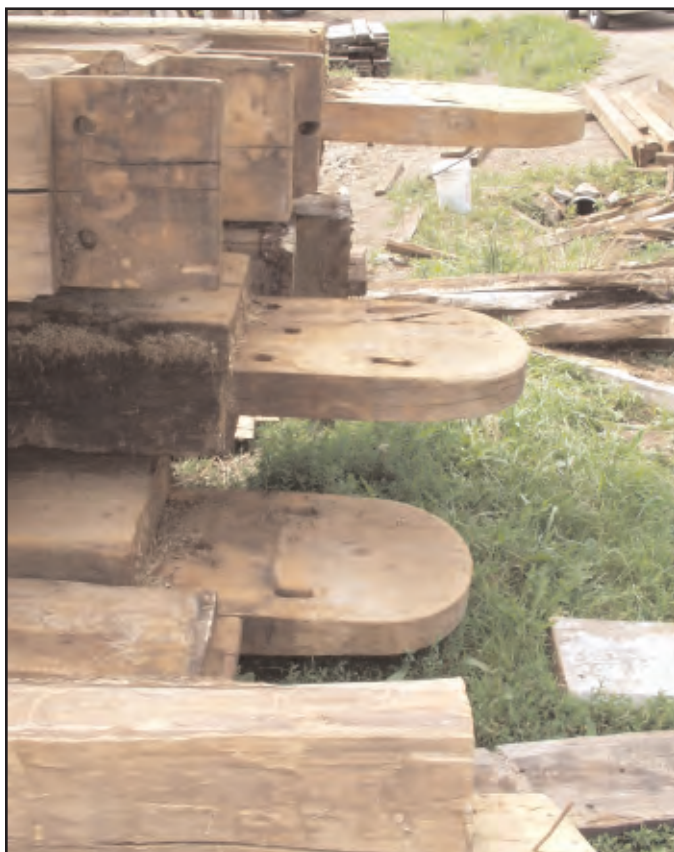
Photo 3. The anchor beams.

measuring 46'-1" deep by 47'-4" wide, with a 26 foot wide center aisle, 10'-8" side aisles, 24 foot high purlin plate and 18 foot high sidewalls. It has 3 1/2"-thick floor planks, with some that are 20" wide. It has the classic Mohawk Valley anchor beams; 1'-7" by 1'-0" with big round protruding tenons with two wedges (Photo 3). These go into stout 1'-0" by 1'-2" posts and are locked together with very nicely made 6" by 1'-0" braces (Photo 4).

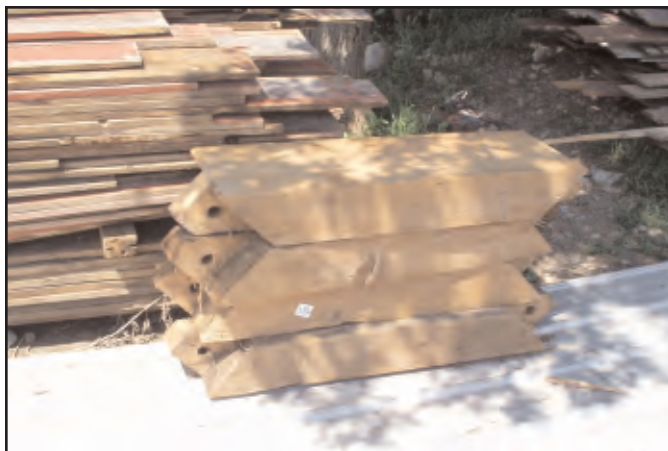
Photo 4. The braces.

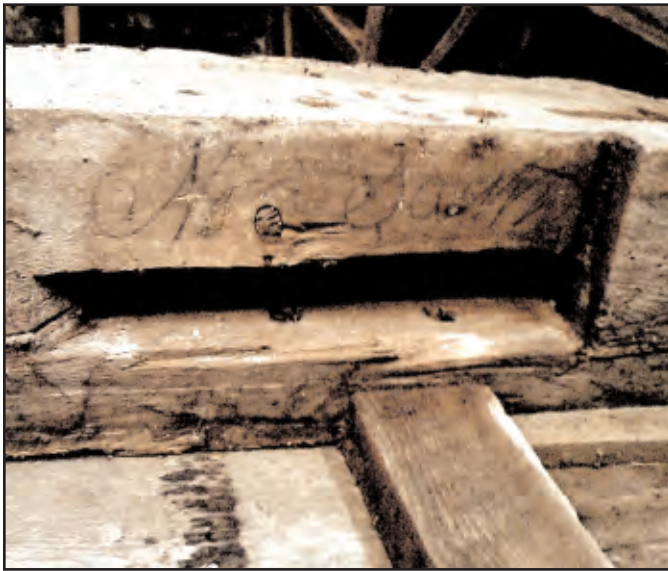
Photo 1. Reused post with "No 3 South" inscribed on its face (L. Lawler).

We thought all those old-time barn craftsmen knew how to read chiseled Roman numerals, but this photo may show a rare surviving written label to aid the assembly of an H-bent (Photo 1). It is on an old post, inside an anchor beam mortise. It is hard to read, but it appears to say "No 3 South".

This post is reused as a loft beam in a large 1870-90 hay barn near Athens, NY. It was discovered during restoration work by Lex Lawler. The writing can only be seen by going under the beam and looking up. There is a late 1700s Dutch frame house on the property.

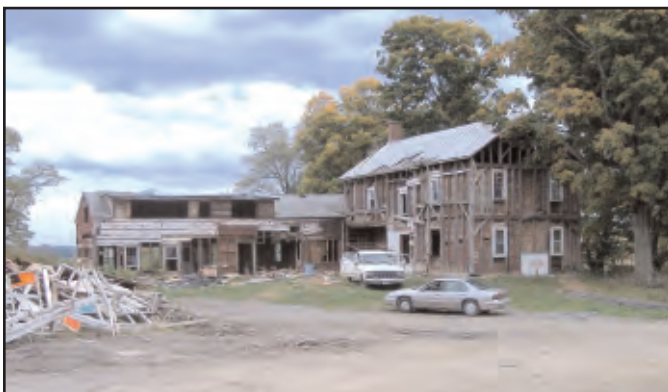
Photo 2. General view of the Houck house, looking southeast, showing the kitchen and woodshed wing at left (W. Wheeler).

County, in November 2005 (Photo 2). Each of the posts in the H-bent framed kitchen and wagon shed addition, dating to c.1850-90, bore red chalk marks indicating their position in the structure (Photo 3).

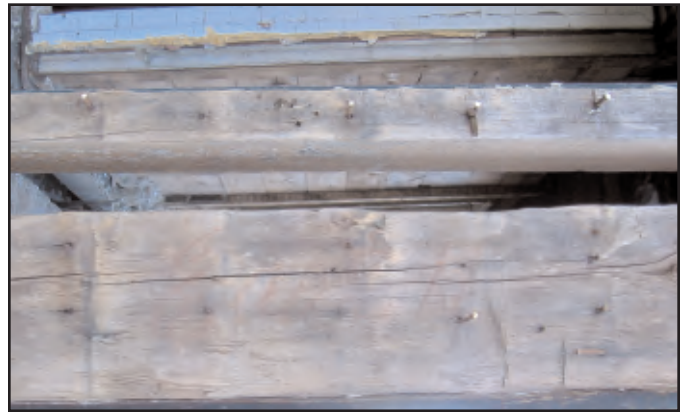
Photo 3. Post with "East II" inscribed in red chalk. Each post was marked similarly, on the outside face (W. Wheeler).

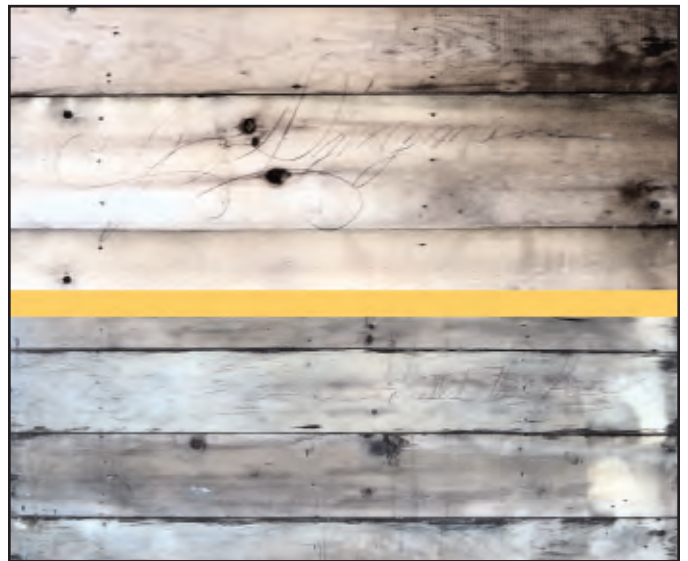
Photo 4. Inscriptions left by J. Dingman and Benjamin Baird in the Houck house kitchen and woodshed wing.

Additional pencil inscriptions on planks attached to the outside walls of the wing are likely contemporary to these chalk marks, and appear to identify two of the builders. One inscription read "Benjamin Baird Buld this House/Amsterdam, N.Y." Baird or someone else overwrote the last two letters of "House" with "ck," cleverly transforming it to the owner's last name (Photo 4, bottom). This inscription was found on a planked surface on the inside of the west wall of the kitchen wing during the course of the house's disassembly.

A second inscription, apparently contemporary with that by Baird, read “J. Dingman” and was located on the inside side of a plank surface attached to the east wall (Photo 4, top). Dingman may have been a partner or an apprentice of Benjamin Baird. A James Dingman was listed in the 1888 and 1889 city directories for Amsterdam, New York as a turner. A John Dingman, a carpenter, lived in Gloversville, New York in 1890.<sup>1</sup> It seems more likely that this second fellow was one of the builders.
