Dendrochronology of the Griffin Barn plus a demolished barn near Saratoga National Historic Park, Stillwater, New York

Carol Griggs
Cornell Tree-Ring Lab
Cornell University, Ithaca, NY 14853

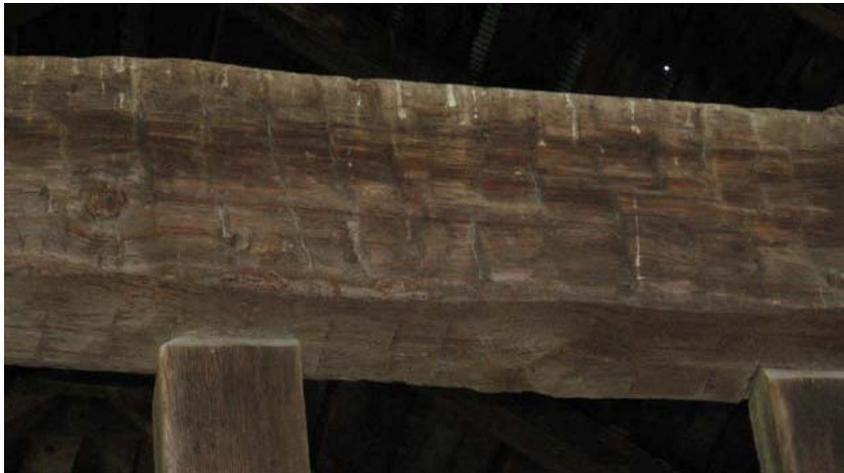
Figure 1. The surface of this beam clearly indicates that it was hand-hewn rather than sawn.

The beams in both the Griffin and the demolished barns are hand-hewn (Figure 1) from pitch pine (*Pinus rigida*); the hayloft floorboards are white pine (*Pinus strobus*). See sample list on last page for descriptions and dates of each sample. Sample SPB-1 is from the outer post on the middle of the west wall; SPB-2 is from the horizontal beam in Figure 1; SPB-3 and 4 are the cross-sections from two floorboards in the hayloft; SPB-5 and 6 are from two posts on the south wall - SPB-6 from the post on the north end of the hayloft and SPB-5 from the center beam which unfortunately had rotted on the inside; SPB-7 was taken from the center post on the east wall. SPB-8, the cross-section, was taken from the largest beam (with waney edge) of several that were lying in a heap below the hayloft. We were told that these beams were from the
