HUDSON VALLEY VERNACULAR ARCHITECTURE

Examination of the Losee house, Rhinebeck

Losee House, Rhinebeck, Dutchess County, NY

Examination of the Losee Dutch barn, Rhinebeck

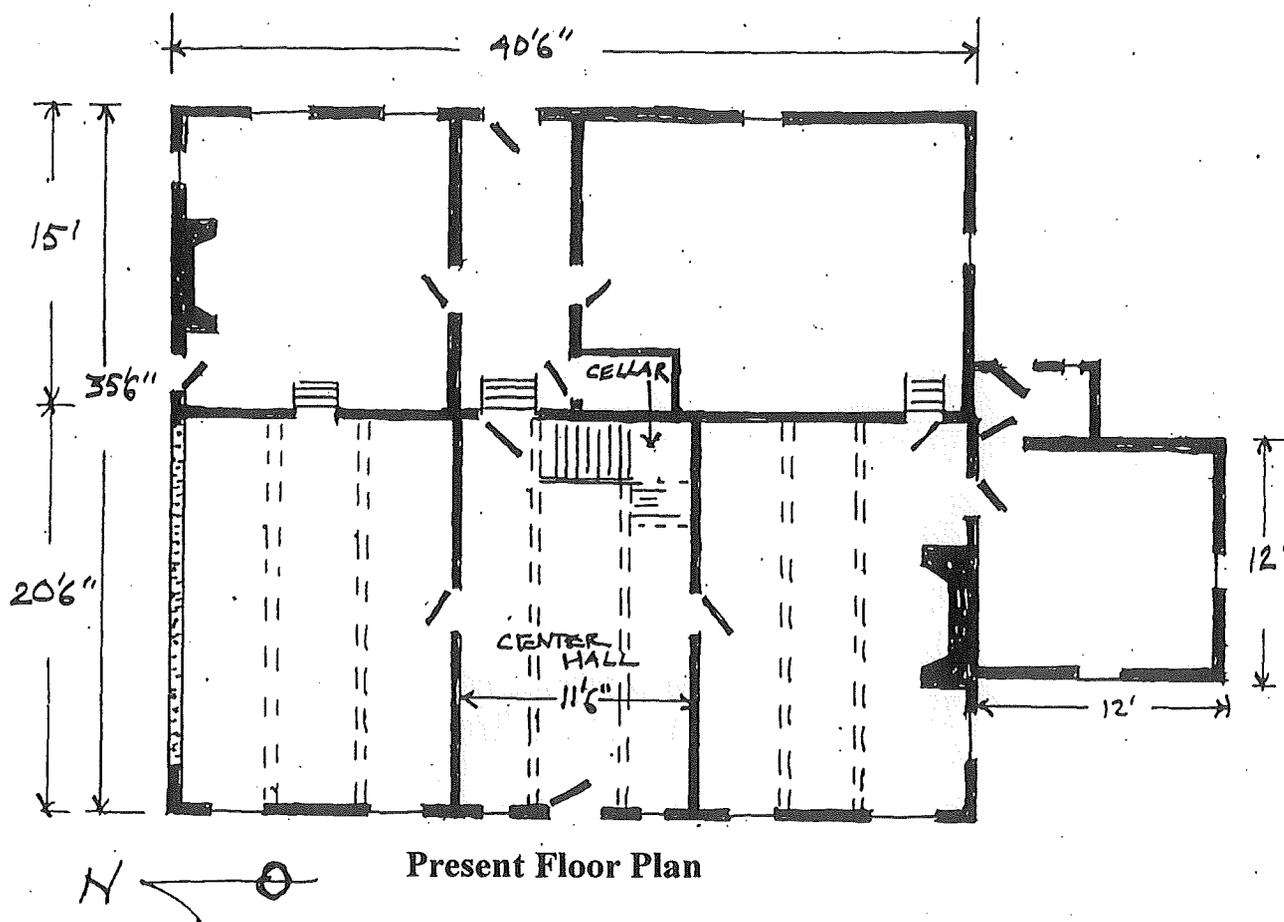
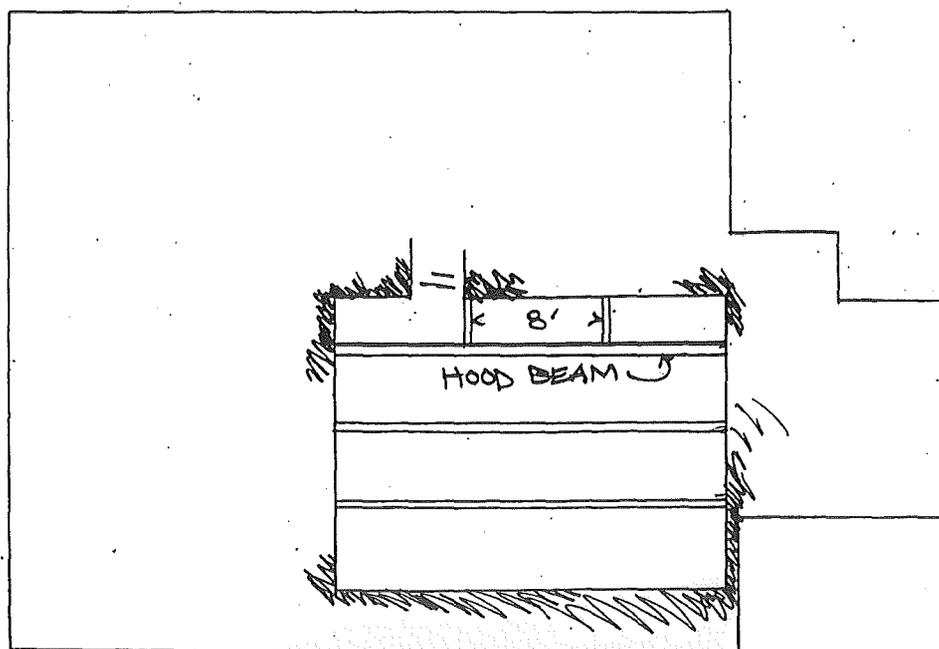
Outline of the present house and location of the 1750 cellar hole with an east entrance and the probable arrangement of the three internal beams of the original one-room 4-bay Dutch/American frame house.

In about 1750 a 4-bay one-room Dutch/American frame house was built with a jambless fireplace. The roof ridge ran east-west, 90-degrees from the present roof line. The evidence of this house survives in the cellar and perhaps in some of the reused timbers and doors. 6-feet of the original 8-foot long stone corbel in the east wall of the cellar is in place. It supported the hearth of the fireplace above. This hearth support was either an arch of brick or an angled cradle of timbers resting against the hearth-beam. The outside measurements of the house were probably 24-foot wide and 20-foot deep. There is no indication of where the door was placed but likely on a side wall. The cellar batten door and frame may be from the original house as well as the re-used false-panel door on the back of the present house. Its iron handle has a Germanic style.

The cellar support system in the Losee house needs further study, but it seems that the 1790 fireplace hearth was supported by a corbelled stone arch at the top of the cellar wall, probably resting against the hearth beam. This is a method sometimes used on Dutch fireplaces where brick was not available. The unusual feature in the loseee house, that might again be the result of frugality or stubborn native habits, is the unique design of the support for the fireplace jambs and chimney. It seems that they originally somehow rested on the hearth-beam that was supported by two posts mortised to its soffit.

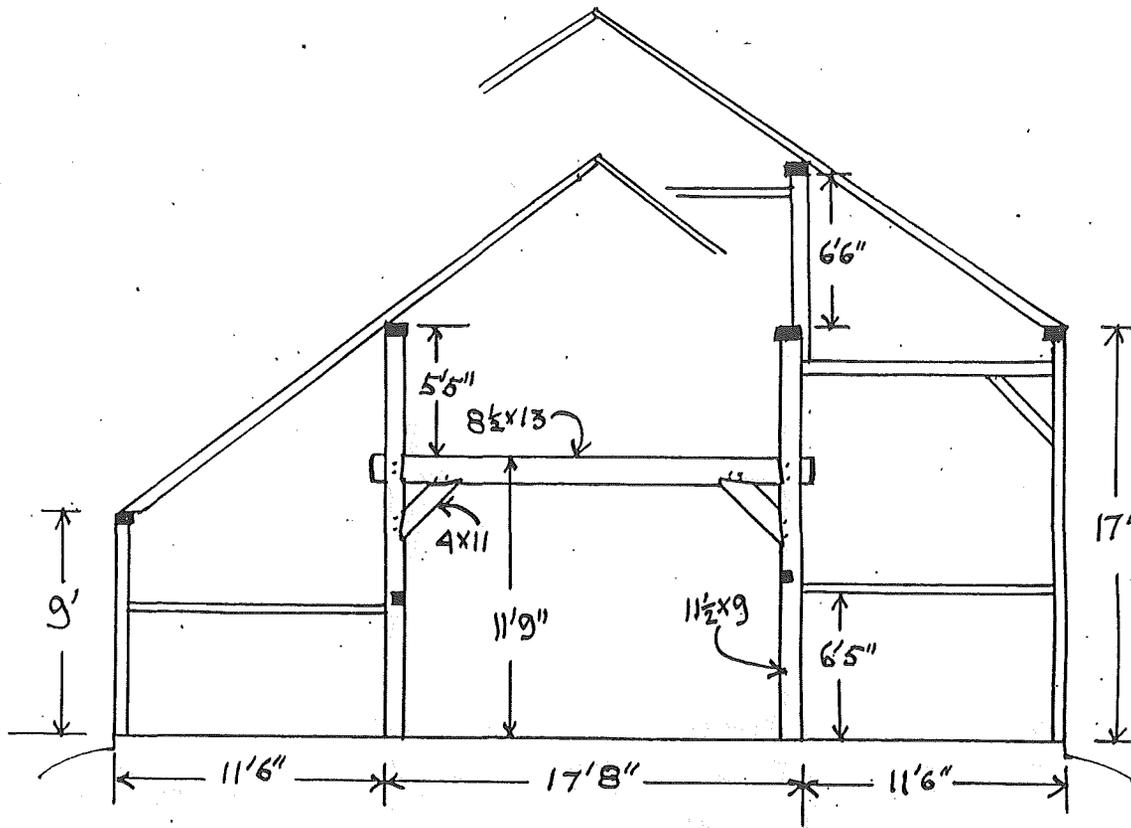
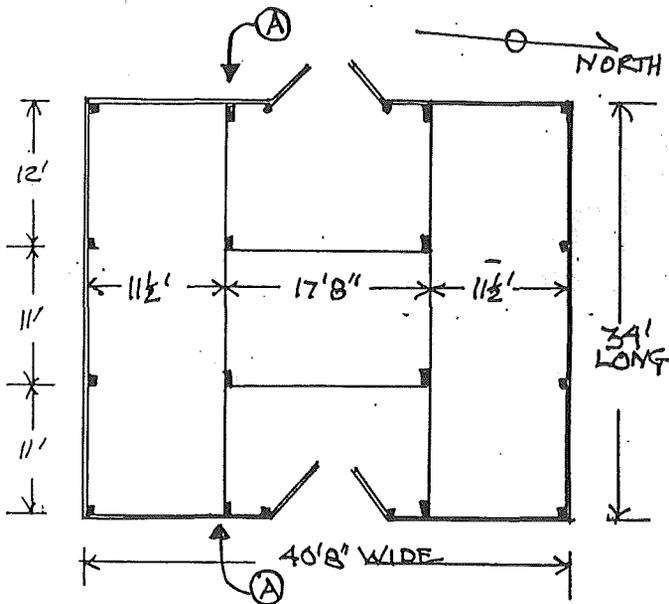
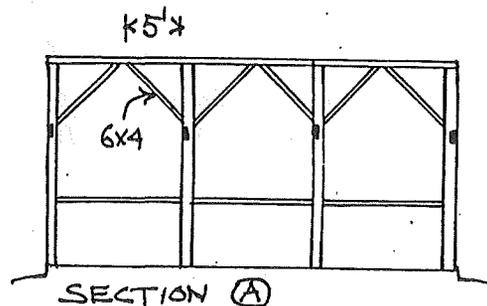
**Internal Bent, Plan and Section A.
Moshier (Dut-RH-18)
and Losee (Dut-Rhi-20)
3-bay Scribe-rule True-form Dutch Barns
circa 1770,**

The right side of the top drawing shows the Moshier barn with its columns extended and higher side walls replacing the original. The left is a conjecture of the two barns' original form. The barns seem to have been almost identical but since none of the original side walls survive, that we could see, it is a conjecture. The plan shows the outward swinging key-hinge wagon doors on the west end and the har-hung doors on the front end. No har-hung wagon doors have survived in place but it seems they would swing in like wooden-hinged wagon doors.

The Mosher barn is a 3-bay Dutch barn with an added bay. Its long 6x4-inch purlin braces, with 5-foot legs, are matched to the columns with gouged marriage-marks, cups on the north side and Cs on the south. Its columns were later extended 6'6" and taller side walls replaced the original ones. The anchorbeam-tenons extend but are not wedged.

Only the center aisle of the Losee barn survives and the columns have been cut down level near the tops of the anchorbeams. It is dated "MD1770" on the first internal anchorbeam. Despite the present differences in the proportions of the Losee and Mosher barns, they were originally twins probably made about the same time by the same carpenters who used many unusual features, such as; the 4x11-inch anchorbeam braces and the 11'6" side aisles. The Losee barn originally had har-hung wagon doors on the front and key-hinged wagon doors on the back.

The original form of the Losee barn could be reconstructed using the measurements of the Mosher Dutch barn
