# The Society for the Preservation of Hudson Valley Vernacular Architecture

## Newsletter

Vol. 12, No. 2-4

## Unique Oliver Homestead in Marbletown, Ulster County with Four Dutch-American Barns

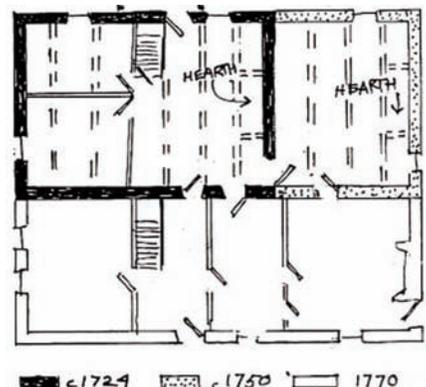
Washington's Headquarters floor plan as drawn by Peter Sinclair.

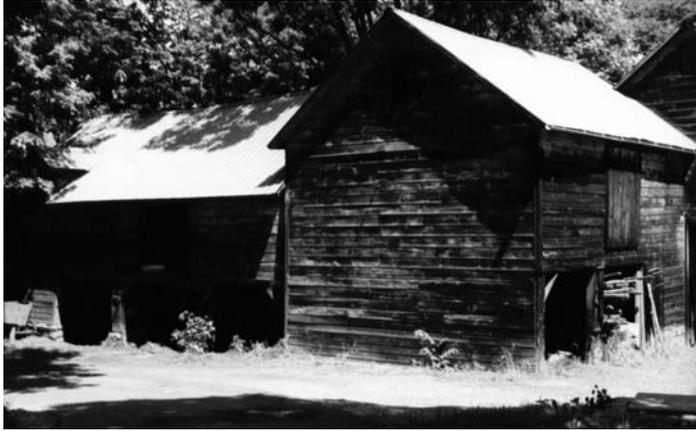
View of south walls of three Oliver barns on Route 209 in Marbletown in Ulster County, New York – four-bay one-aisle barn at the left, three-bay barn in middle and the four-bay classic barn on right. Cladding on all three barns is not original.

The four Oliver barns are all connected – one to the next. As one approaches from the driveway the first two seen at the left are one-aisle barns. The first is a four-bay barn and the second is a three-bay barn. Then to the north of the three-bay barn is the four-bay three-aisle classic barn. This is the best known of the barns and it was originally a three-bay barn. Last is what may be basically classified as a three-bay three-aisle barn. All four barns have their own distinctive nature and each tells a story. The Oliver homestead is unique as the only Dutch-American farm in either New York or New Jersey that has four Dutch related barns. The Bogart farm in Marbletown discussed in an earlier issue of the HVVA Newsletter has three Dutch related barns – the superb circa 1790 four-bay classic barn and two one-aisle barns.

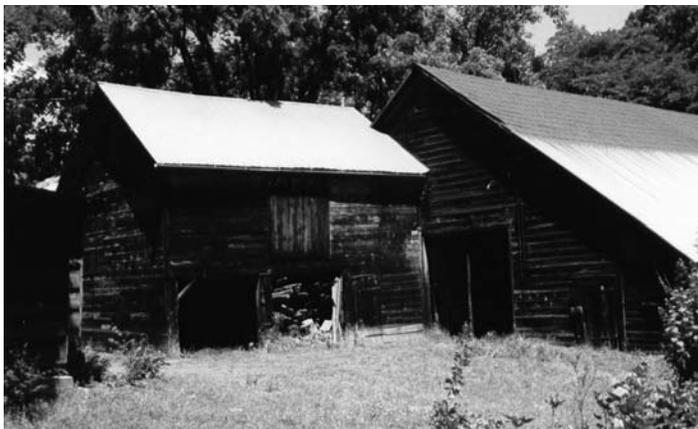
View of south wall of three-aisle classic barn at right and two walls of three-bay one-aisle barn at left at the Oliver homestead.

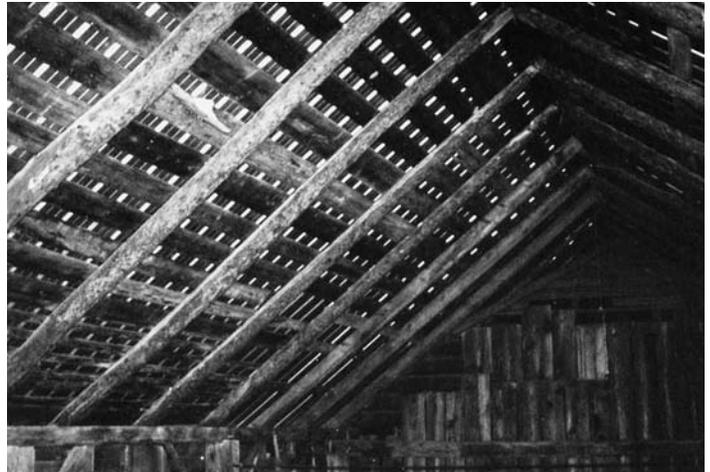
View of roof structure of one of the one-aisle barns at the Oliver homestead. Rafters are round poles.

Twelve round pole rafter pairs are seen and all rafters are pegged at their tops. As to be more or less expected the rafter pairs at the end walls are completely hewn. Both wall plates are hewn and interestingly enough are spliced. Side wall braces are hewn and this aspect helps to establish the date of construction likely in the first quarter of the nineteenth century. The side wall studs are either round pole or milled and are secured to braces with cut nails. All wall posts (H-frame posts) have raising holes. Most wall posts are hardwood with oak as the major species. One post is softwood.

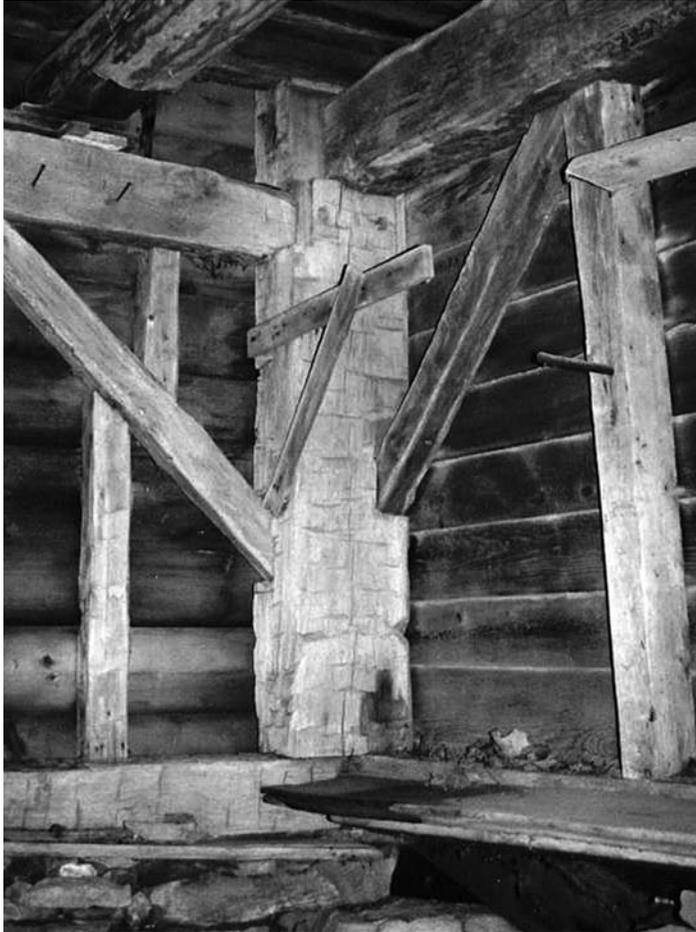
View of the substantially sized oak corner post in one of the one-aisle barns at the Oliver homestead. In upper left corner large round pole joists are seen to support floor above.

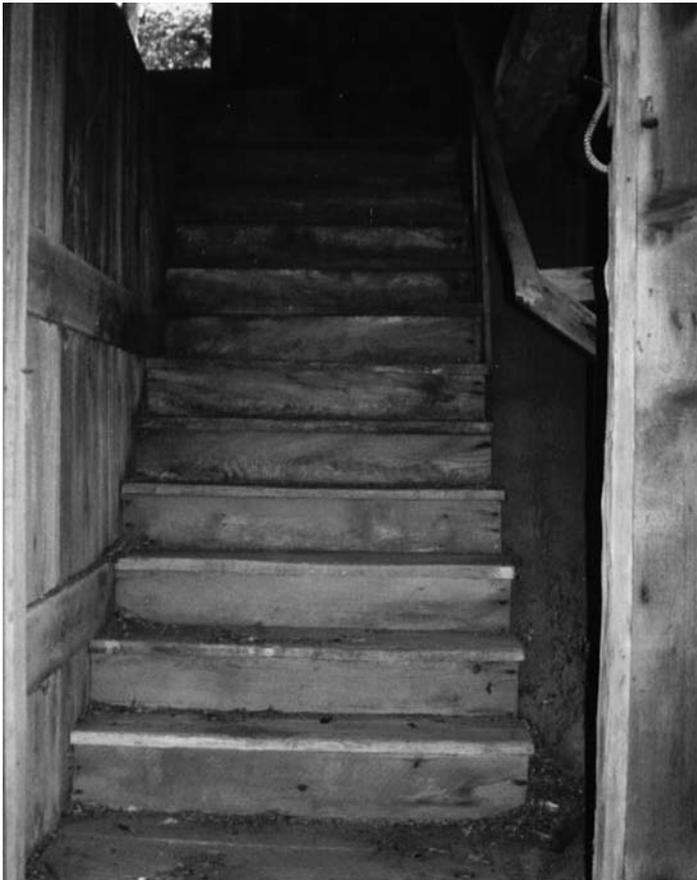
View of staircase in four-bay one-aisle barn at the Oliver homestead.

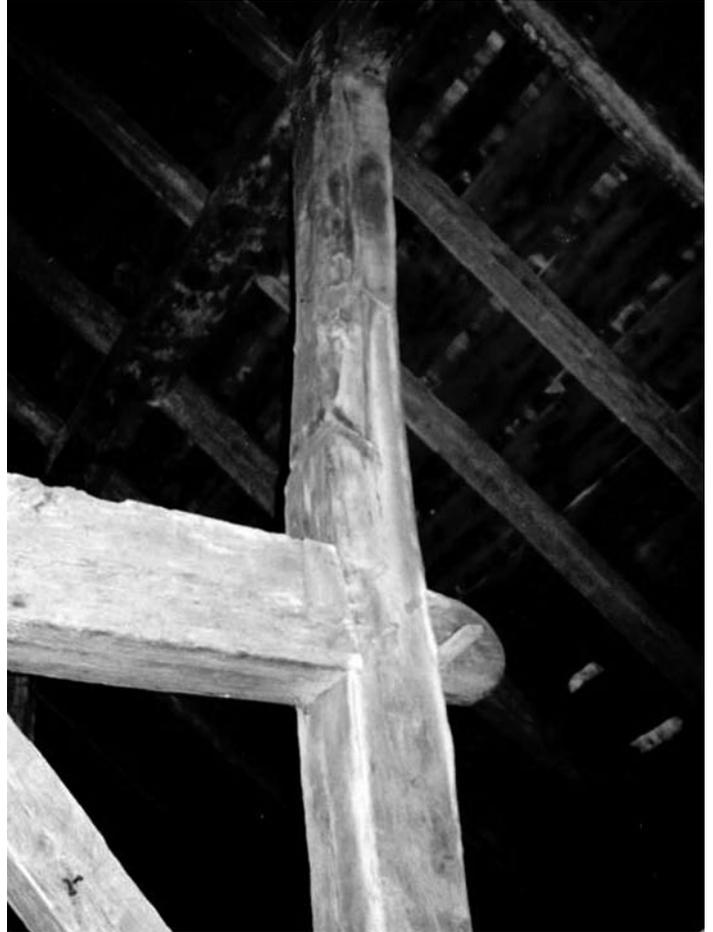
View of H-frame post that was later spliced circa 1830 in four-bay three-aisle classic barn at the Oliver homestead. Note hewn rafters in common rafter system in roof.

In the post 1825 to 1835 agricultural environment and beyond the basic mode of the very squat aspect (with very short *verdiepingh*, low side walls and steep roof) of major-minor rafter barns proved to be inadequate. Severe modifications had to be brought about in such barns for farmers in Ulster County to compete with other farms and barns in the northeast in the Industrial Revolution. The three-bay Oliver barn was no exception. Extreme innovation was employed at the homestead where uniquely the barn structure was actually separated in that the purlin plates were lifted and a new H-frame was then inserted between the end bent closer to the stone house and the first original inner bent. This new bent is presently the first inner frame closest to the house. The “new” anchor-beam has a two-foot scribe mark whereas the others following typical pre-Revolutionary War era tradition do not. The new H-frame posts have raising holes where the original frames do not. This last condition is due to the fact that new sections of beams were spliced onto the original upper post extensions of the H-frames. Thus the posts were lengthened

by about three feet or so. The “new” *verdiepingh* measures 75”. The new posts do not have raising holes.

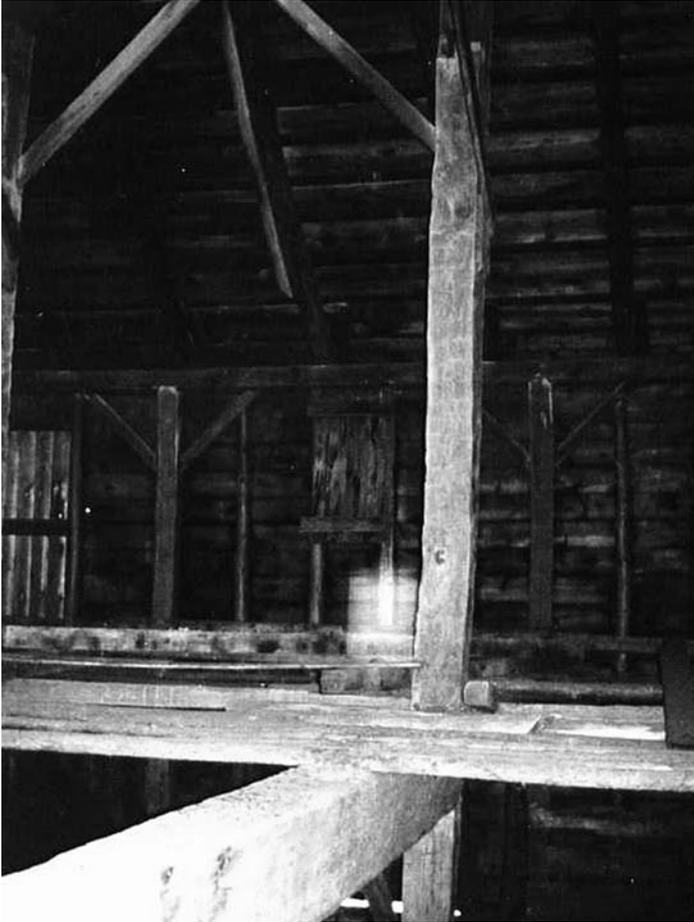
View of H-frame with long post in three-bay three-aisle barn at the Oliver homestead. Very long 15½' *verdieping* of H-frame. Note short purlin brace at top of post.

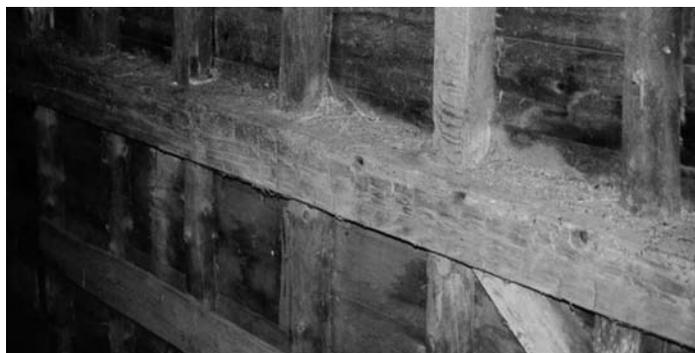
*View of recycled hay-barrack post at north end wall in bent in three-bay three-aisle barn at the Oliver homestead. Note holes at corner of post that functioned in raising and lowering of adjustable roof in former hay barrack. Round pole studs appear above and below the post.*

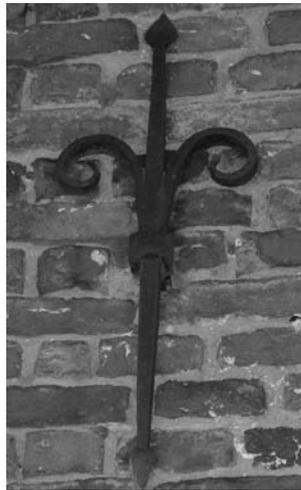
Tie-irons to hold sheathing to the wooden frame.

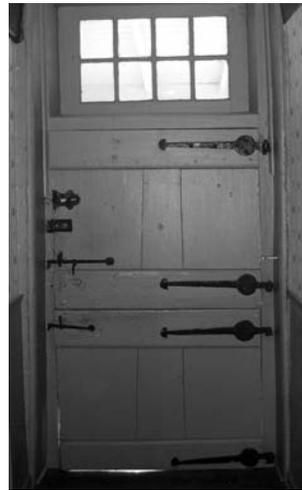
Divided doors – a.k.a. Dutch doors.

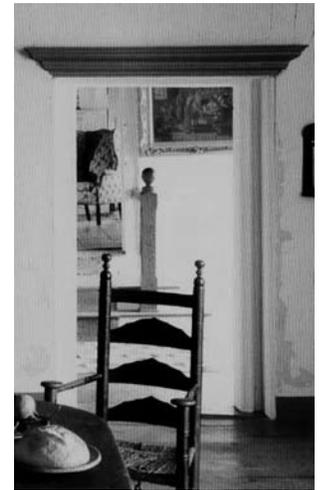
Molded wooden cornice above doorways.

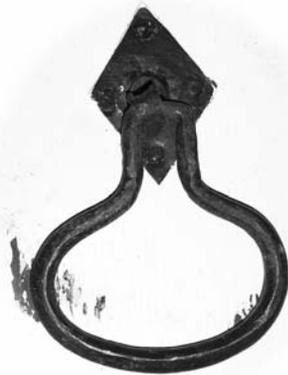
Dutch knocker latch found on many early doors.

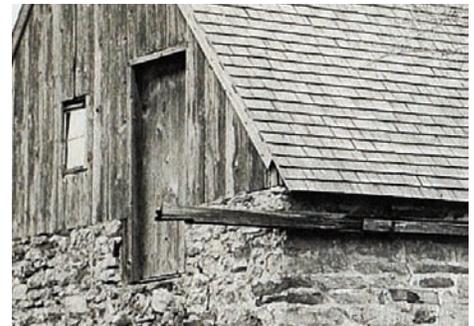
Granary doors to load grain into the garret for storage.

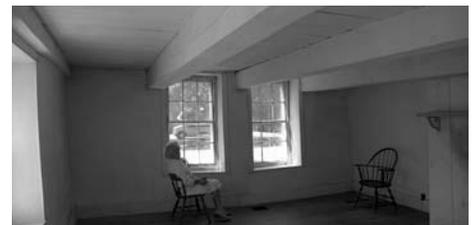
Smoothly planed exposed interior beams.

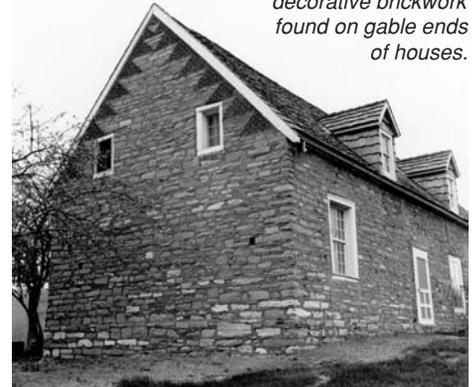
Vlechtingen decorative brickwork found on gable ends of houses.
