The Society for the Preservation of Hudson Valley Vernacular Architecture

November – December 2009 **Newsletter**

Vol. 12, No. 11-12

Wagon Doors in Dutch-American Barns (Part One)

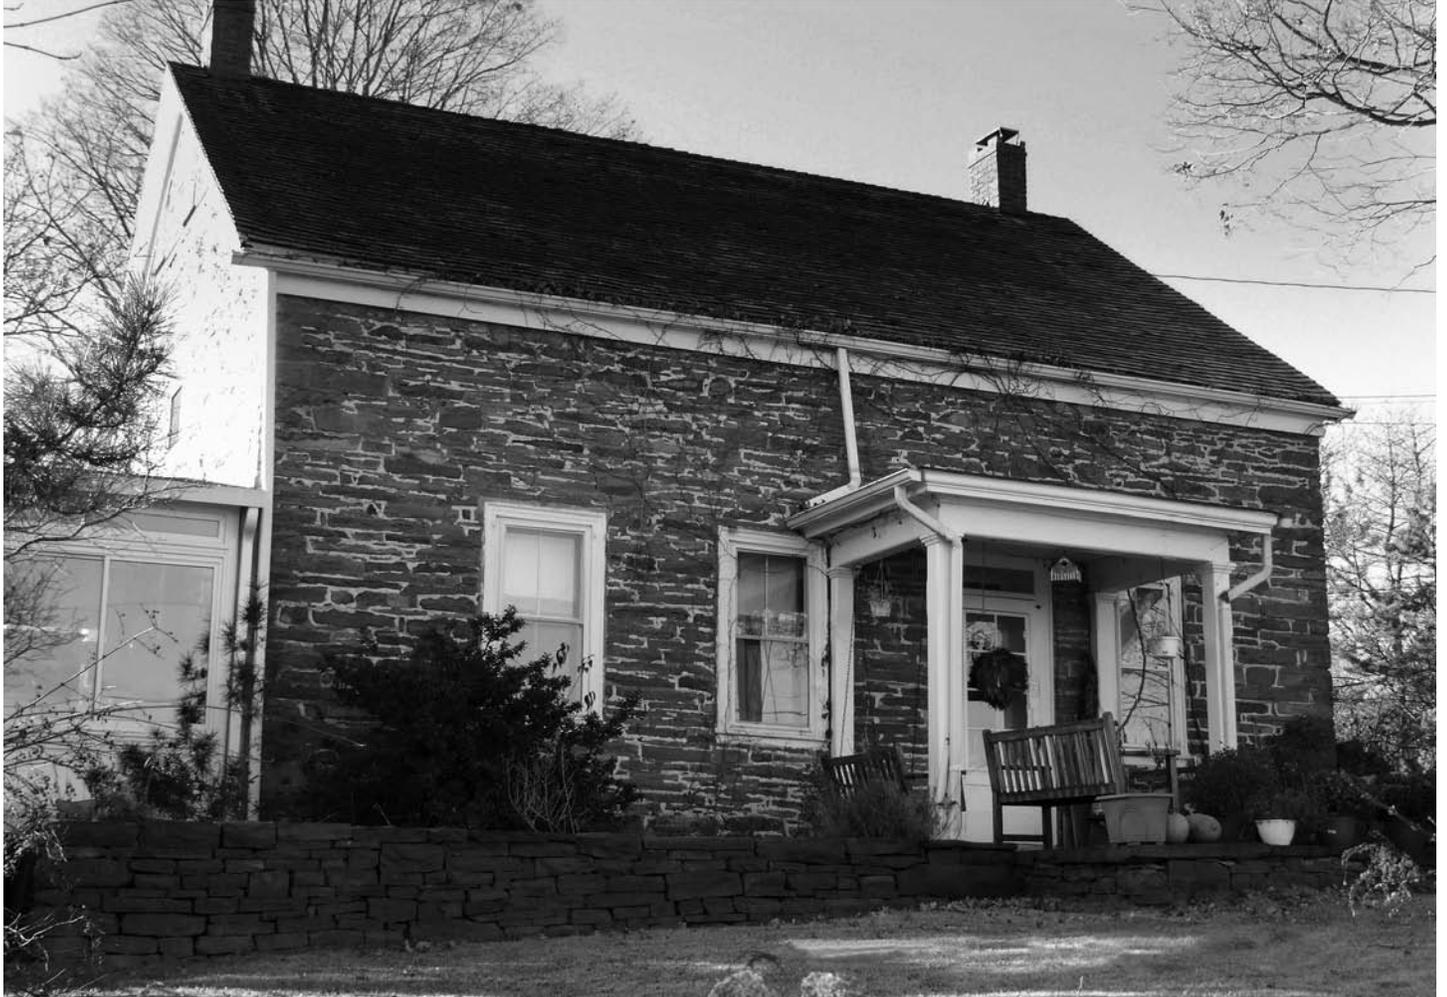
Where, oh! where could this house be?

Just a few hundred yards north of and across the street from the John L. Jenkins house (aka Maplestone Inn) is another stone house at 520 Route 32. If one was not paying attention, they would drive by it quite easily as it is surrounded by a stockade fence blocking most of the charm of this very vernacular appearing structure. Throughout the generations that resided in the home, the original footprint was never changed or expanded. The house is now owned by Sanford Levy, proprietor of Jenkinstown Antiques. According to his website, the house was built in 1726 by the Freer family, most likely as a tenant house. One possible tenant could have been John Sloat during 1779, identified by historian Kenneth E. Hasbrouck. The property being only a half mile

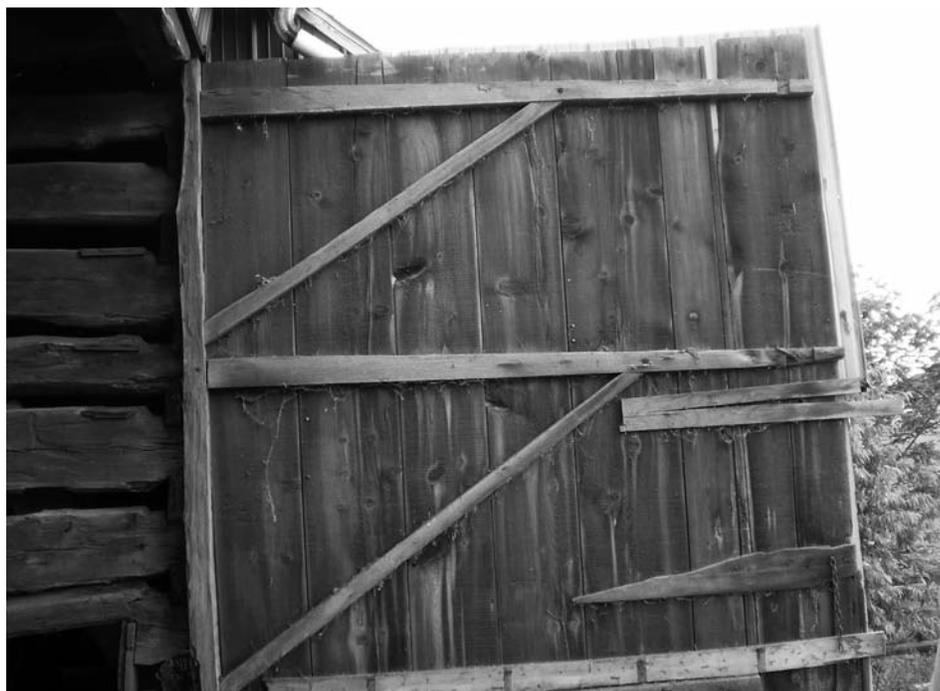
Possible pre-Revolutionary War era Gebhard double log crib Switzer barn east of Gettysburg, Pennsylvania. Original side wall wagon door is seen at the one side of door opening. Note the three tapered horizontal bars and two diagonal bars that are framed into single vertical stile at extreme left of door. Note logs of log crib at the left.

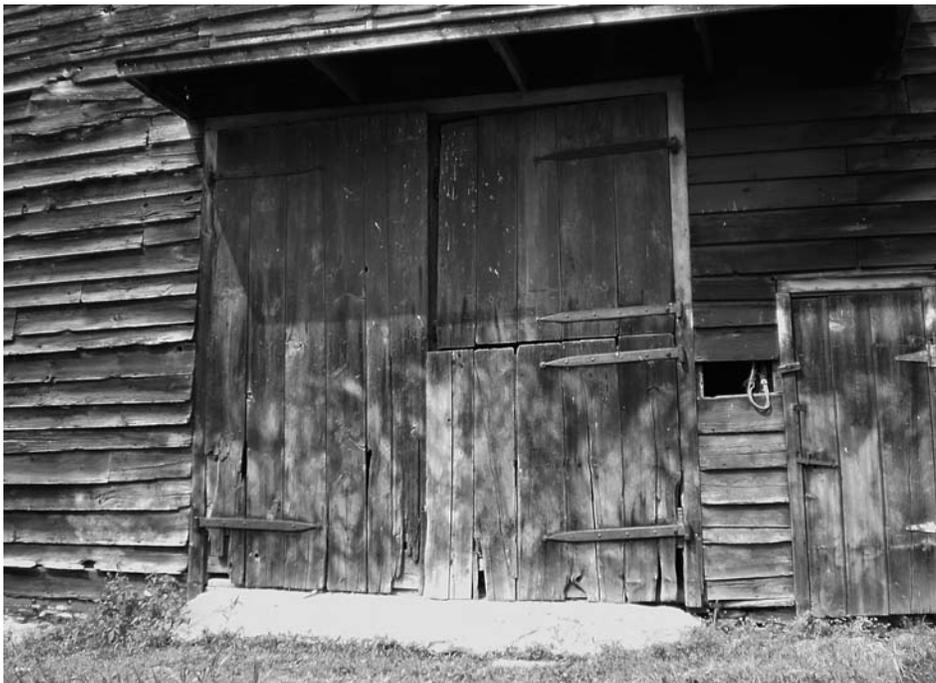
Colluci side wall entry English barn near Gardiner in southern Ulster County with three section nearly original wagon doors. Full height door appears at the left and two half door sections are seen at the right. Pentice is seen over the wagon doors.

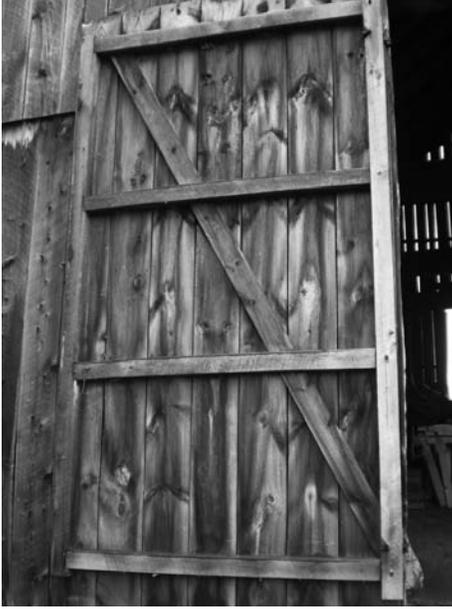
William Bull dendro-dated 1726 three-aisle barn near Goshen in Orange County, New York. View of far end wall with one frame wagon door section is shown.

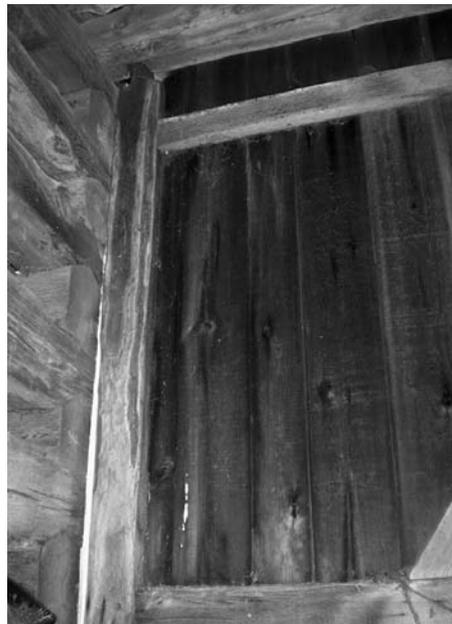
Double log Switzer is seen in Weisenberg Township in northern Lehigh County, Pennsylvania. Top end pin extension of vertical wood stile of rear wall wagon door of frame construction is inserted into hole in lintel above door opening. Wagon door opening is 11 feet 10 inches high by 15 feet wide.

Perhaps half a dozen Dutch barns have been seen with them. The vertical wood pieces (stiles) of these doors have wood pin extensions (several inches long and integral to the stiles) that engaged circular holes in the soffit of the overhead door lintel (anchor-beam) and also the floor sill. Thus the door pivoted on this vertical piece. A much altered pre-Revolutionary War era barn near Red Hook in Dutchess County, New York apparently had harr-hung wagon doors. Another barn of eighteenth century vintage in Hunterdon County, New Jersey near Oldwick also likely had harr-hung doors. Another but much altered barn in Columbia County on County Route 11 had the door type at least at one end wall. The dated 1770 nave only remnant barn near Red Hook in Dutchess County had a harr-hung wagon door. The doors themselves in all the barns are non-extant but the circular holes in the overhead beams are still plainly evident. Four or five barns in southeast Pennsylvania have intact harr-hung wagon doors. So – not including any harr-hung doors on barns possibly existent in New England such particular frame constructed doors in regular sized hay barns are very un-common in the northeast. Perhaps locally in certain areas they may be seen.

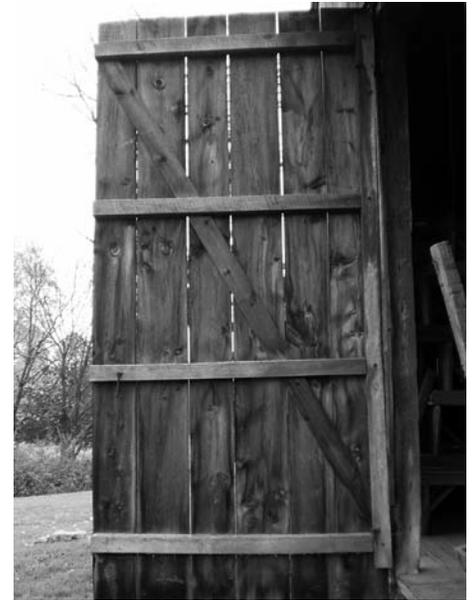
Near end wall of Bull barn is seen with its interior surface of full single height door section. Note four horizontal bars that join to side vertical stile in frame constructed door patterned after possible original wagon doors.

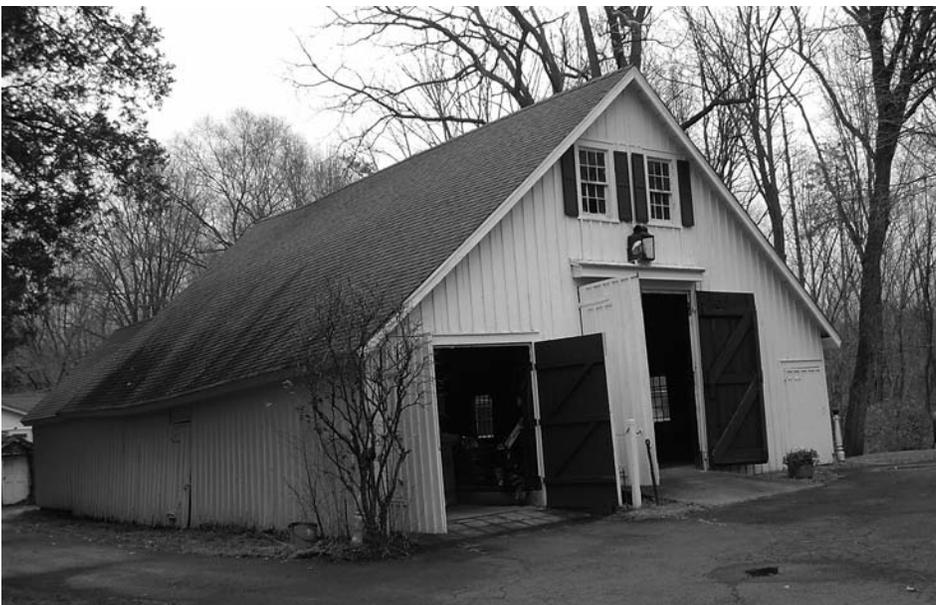
Bartholf circa 1800 three-bay three-aisle barn with one-bay addition is seen on Route 202 in Mahwah, Bergen County, New Jersey. Barn only had one end wall wagon door opening.

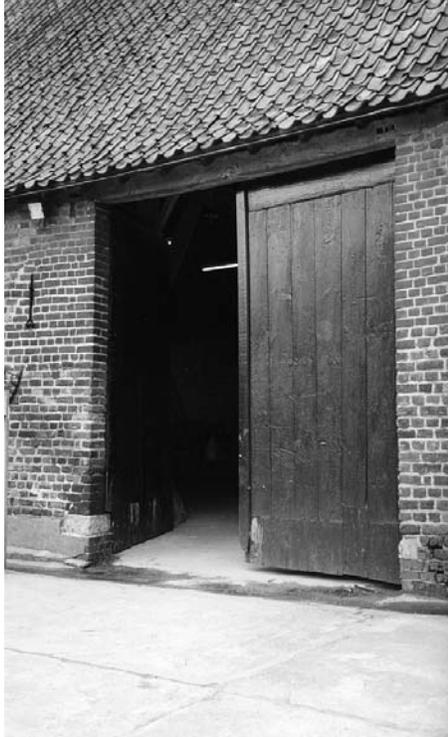
Van Den Bekken farm is located in Kessel area of Limburg near Maas River in the Netherlands. Barn has original frame constructed wagon doors that open into barn. Farm buildings are in court yard arrangement. A date of 1818 in irons is seen on homestead house.

barn had original frame constructed eave wall wagon doors and they opened into the barn. The farm buildings were in a court yard arrangement (*carre*) and there was a date of 1818 in irons at the front gable wall of the house section. At the time of the visit the barn was apparently 185 years old. The doors had an appearance and size just like they were right out of New York State. All the rear face wood framing elements were mortised and

tenoned with pegs. It seems likely that the doors were based on traditions that went back at least a century or two or more before the barn was constructed. The barn had classic ankerbalk (anchor-beam) oak construction with extended and wedged tenons nearly identical to Dutch-American construction.

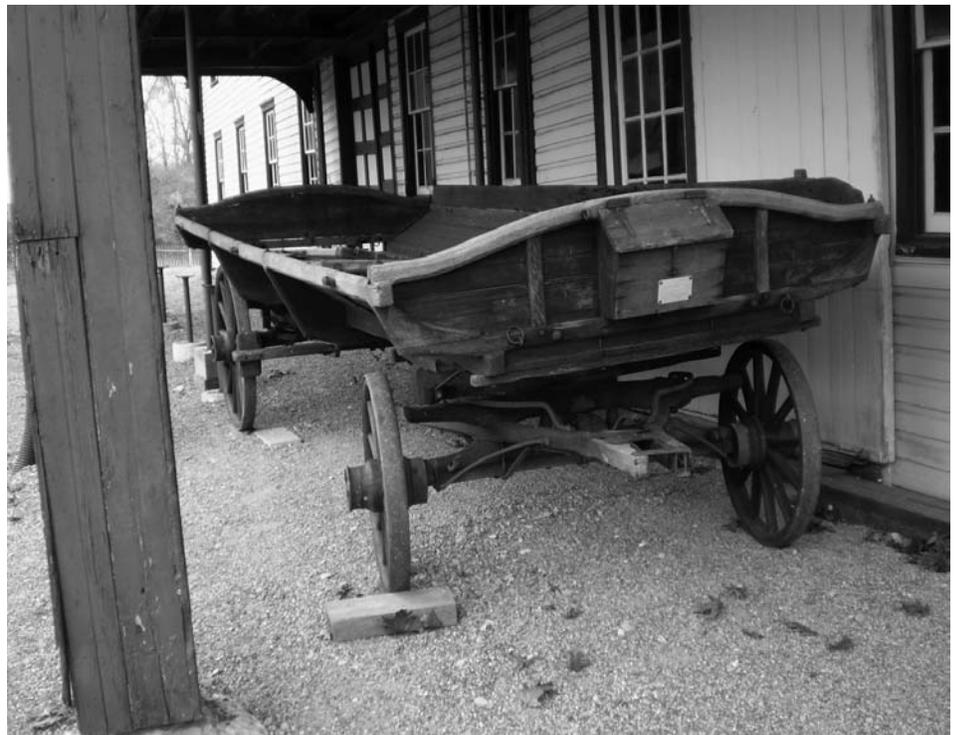
Pennsylvania hay wagon is shown at the Gruber Wagon Works north of Reading in Berks County, Pennsylvania. This wagon is an early twentieth century model. Wagon is four feet high on each of the sides.

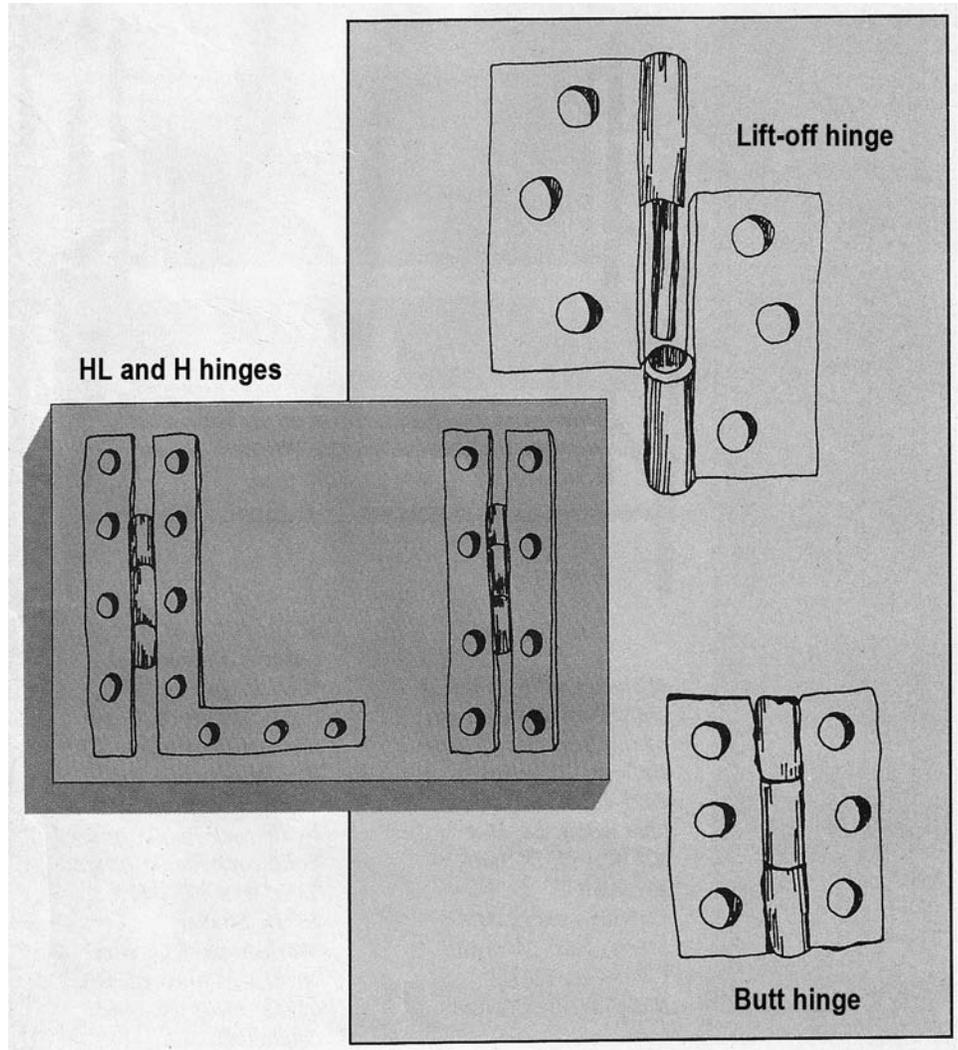
Around 1800, the less obtrusive cast-iron butt hinge was introduced and quickly became very popular. A cast butt hinge is mounted in inlets (or mortises) cut into the door edge and the jamb. When the door is closed, only the hinge's knuckles are visible. While H and HL hinges were usually attached with clenched nails, cast butt hinges had to be attached with screws, as a nail driven into the edge of a door cannot be clenched and would pull loose under the door's weight. For a while it was common to find both types (butts and H or HL hinges) in the same house. Doors in important rooms were hung on butts, while H or HL hinges were used in lesser rooms.

Many H and HL hinges were imported from England, and colonial blacksmiths made them here, too. Cast butts were also made in England and exported to America. When imported cast hinges were not available, local blacksmiths sometimes made wrought-iron

butt hinges. During the Industrial Revolution, America began to produce more and more of its own hardware, including cast butt hinges. The cast-iron butt hinge remained standard until well after the Civil War. An interesting variation of the butt hinge was the two-part, lift-off hinge that allowed a door to be removed without withdrawing the screws. Both cast butt hinges and lift-off hinges often bear patent information that makes it possible to date them.
