The Society for the Preservation of Hudson Valley Vernacular Architecture

April – June 2010

Newsletter

Palatine Tri-centennial - Notes on Germanic Buildings

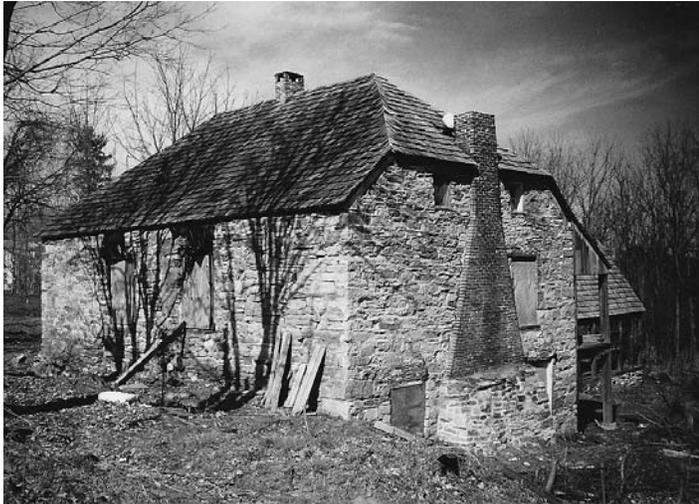
West Camp House

The West Camp House, Ulster County, New York

This one-and-a-half storey stone house stands on the east side of route 9W in Ulster County, a few miles north of Saugerties. It is approximately opposite the Village of Germantown, on the opposite (east) side of the Hudson River. Its main elevation faces approximately east (we need better compass orientation for the house). It is 36 feet east-west in length, and 25 feet, 7 inches in depth. It is built end-on into a bank so that there is a full-height exposure of the basement walls at the south east corner. The south basement room was a finished

space, with the first floor beams and the underside of the floor boards carefully planed. There is a doorway in the east wall (with the date mentioned painted over it) having a divided door. To the south of the doorway there is a casement window. There is a shallow fireplace on the south wall having a brick bypass flue that shows prominently against the stone of the south wall. The north room shows rough-hewn floor beams, and rough-sawn floor boards. The fireplace hearth for the floor above is supported on stone piers engaged with the partition wall. Access from the first floor is by a stair in the north east corner, underneath that to the attic.

The original casement window frame with its shutter survives in the east wall, centered in the south room. Mr. Gemberling found double-hung windows- two in each of the first floor rooms, and mistakenly determined that the house originally had cross-windows, which he had made up and installed.

In the attic, Mr. Gemberling found good evidence that the house originally had 'docked' gables, and restored these. Several other houses survive with similar evidence – notably Rob Sweeney's Benjamin ten Broeck house; the Mathew ten Eyck house on Hurley Mountain Road in Hurley (see *DVAinNA, Plate 30B*), and the Jonathan Hasbrouck house (Washington's Headquarters) in Newburgh (See *DVAinNA, Plate 19*). These three houses are contemporary with the West Camp house.

Summary: 'Germanic' characteristics of the West Camp house might be:

(a) its being built end-on into a bank to provide a full elevation for a basement kitchen. This feature has been found in a number of houses on both side of the Hudson River in the area where the Palatine Germans are known to have settled. The Lutheran Parsonage in Schoharie (c. 1743) is a timber-framed example (See *DVAinNA, Plate 20*), and the stone-built Lutheran Parsonage in Germantown can also be considered. This could be the topic of a comparative study.

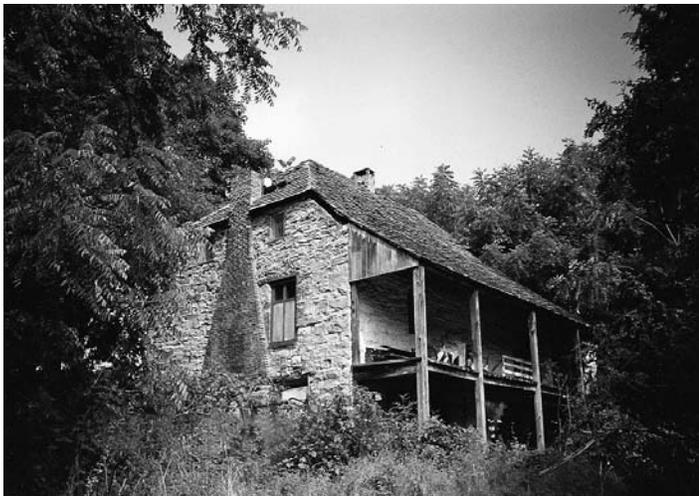
View showing the North-East corner of the West Camp House, circa 2003.

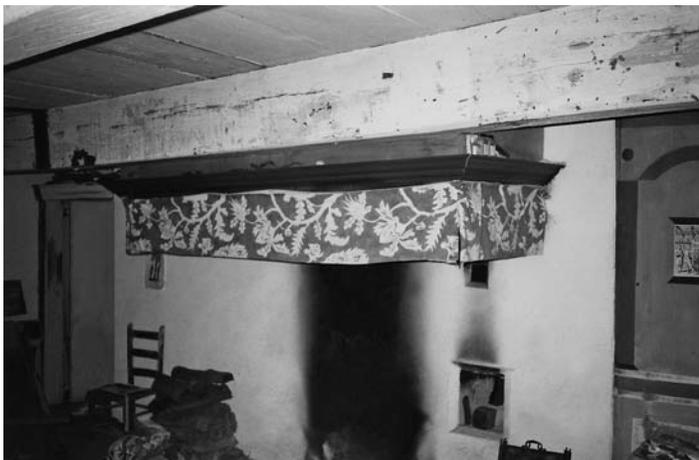
Interior view of the West Camp House showing the restored hearth, circa 2003.

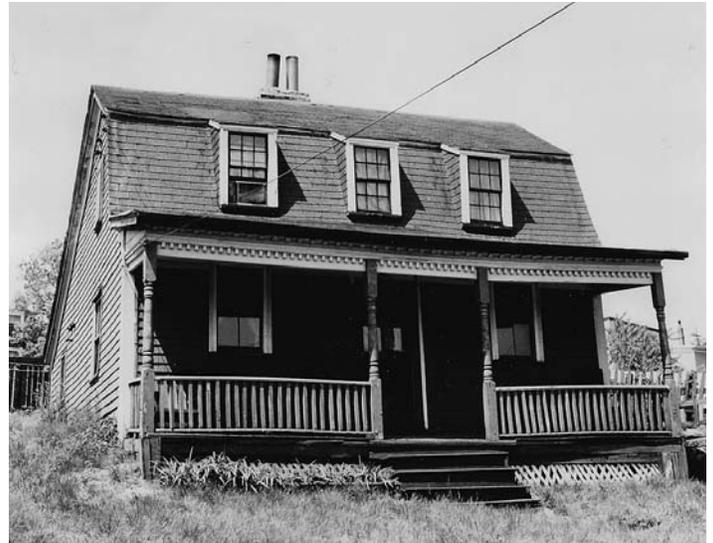
Conrad Burge House

Conrad Burge House, Barrington Street, Halifax, Nova Scotia, circa 1968.

City of Halifax which had taken it for a road access scheme – it was near the end of the bridge across Halifax Harbour to the City of Dartmouth. What I found was a one storey, two-room house of horizontal log construction using corner and door posts into which the logs were morticed with complex joinery. The roof framing was a particularly fine example of 'Germanic' timber-framing. Marion researched the property at the Halifax Court House and determined that the house was built by Conrad Burge (also spelled Burgie) about 1755. My suspicion is that he came from a part of Germany adjacent to Switzerland, and possibly from Switzerland itself. The mode of construction is akin to that called by the French *piece-sur-piece a tenon en coulisse* – which was adopted by the Hudson's Bay Company for the construction of trading posts in the West, where it was called 'Red River Frame.'

not long after I measured it. It was certainly the oldest surviving house in Halifax, and quite possibly in Nova Scotia, too. The type of construction exemplified by the Burge house I am sure was represented in the County and the Town of Lunenburg on the Atlantic Coast, which was a major settlement area for German 'Palatines'. I am not aware of any survivals in Lunenburg County like the Burge house. However I have seen several examples of houses of later date (late 18th, early 19th centuries) in 'semi-demolished' state that employ a construction technology perhaps based on Germanic precedent. These have heavy main posts that have rabbets for the reception of the bare-face tenons on the ends of approximately three inch thick horizontal planks. I am not aware of anyone having done a study of houses of this construction.

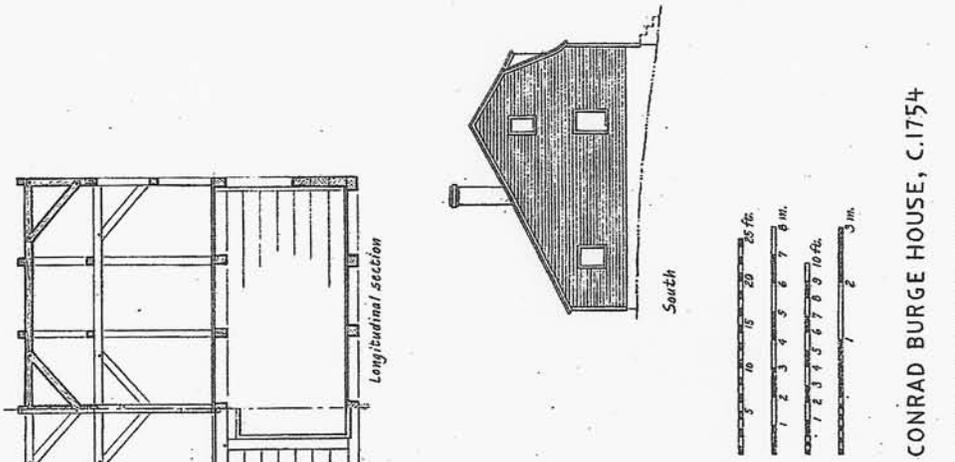
CONRAD BURGE HOUSE, C.1754
 JOHN R. STEVENS, 2003

When I was working on the Halifax Architectural Survey, 1963-65 with my wife Marion, I was intrigued by a small half-gambrel house on Barrington Street, not far from the 'Old Dutch Church' and also close to the naval dockyard, which now serves the Royal Canadian Navy. While I was able to make an interior inspection of this house, modern finish almost completely concealed its structure, except for the underside of the first floor, and wall framing inside a lean-to addition.

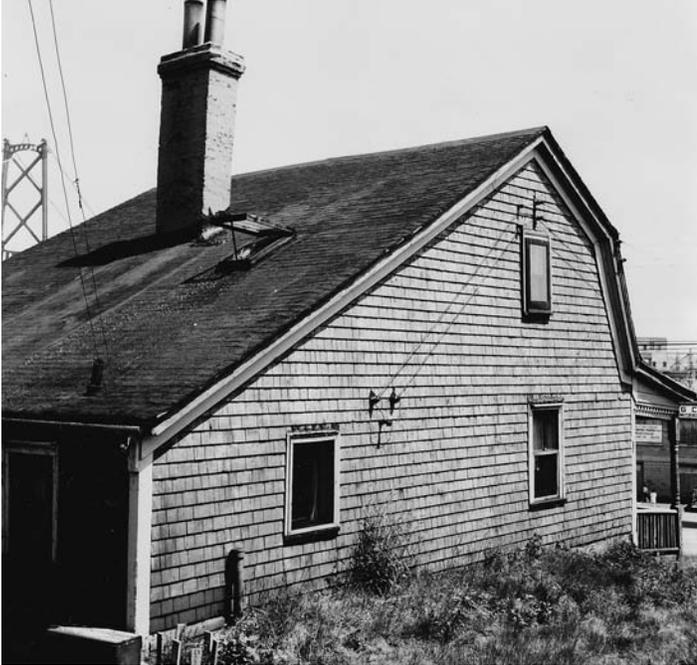
Side view of the Burge House.

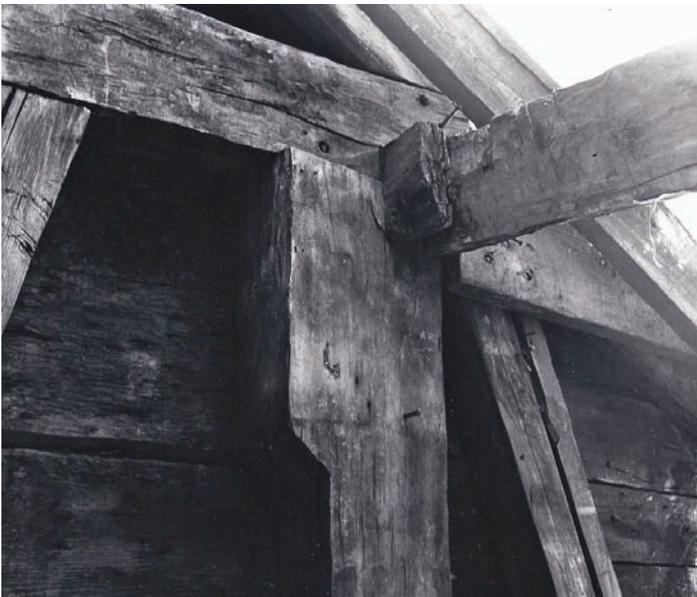
Detail of the Burge House framing joint, circa 1968.

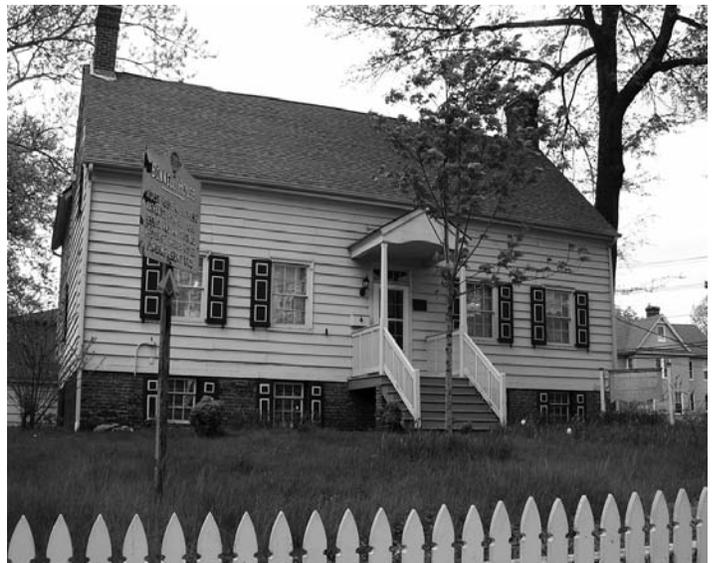
For example, one of the main features of last issue's column should have been the Konradt Lasher house, on Route 9G in Germantown in the northwest corner of the intersection with Jug Road – also identified by the New York State historical marker as the “Stone Jug.” Listed in the National Register of Historic Places, in the nomination report submitted, it is mentioned this is the only extant house of the three brothers that built their stone houses in close proximity of each other so as to share one well for water. The report states that the ruinous foundations of George and Johannis' homes are still visible on the 9.67 acres property after being demolished between 1845 and 1873. It is believed that all three brothers erected their houses at the same time. There is an inscription carved in the stone lintel above the east door with the year 1752 and the initials “K.E.L. & J.” The origins of the Lasher family in the New World goes back to Bastin Lescher or Lasher, who was part of the 1710 emigration and choose to remain in East Camp as a tenant farmer. The nomination report, submitted in 1977, goes into much detail about the architectural composition of the house and can be accessed through a link on Wikipedia, which in turn can be reached by clicking on the link on the house's placemark on the HVVA Columbia County map site.

Konradt Lasher house (1752) in Germantown. Showing the west & south elevations still original to the house. Note the diamond designs in the brickwork of the gable.

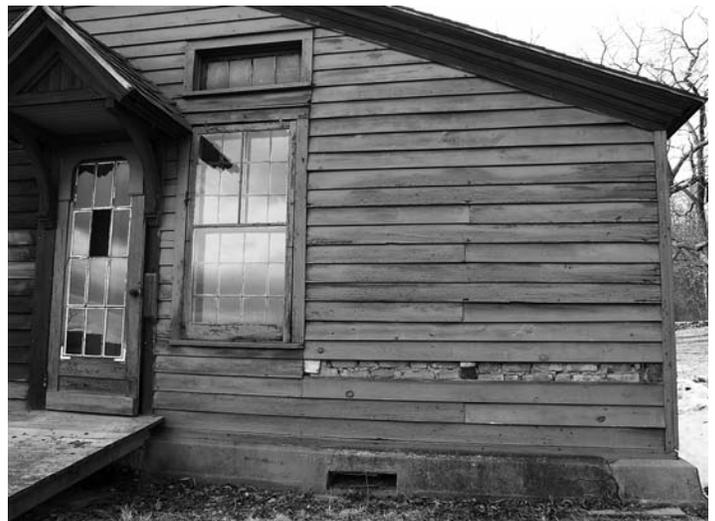
The lean-to additions on either side of the Brandow house appear to be built soon after the main section as evidenced by the exposed brick noggin seen here in the north addition.

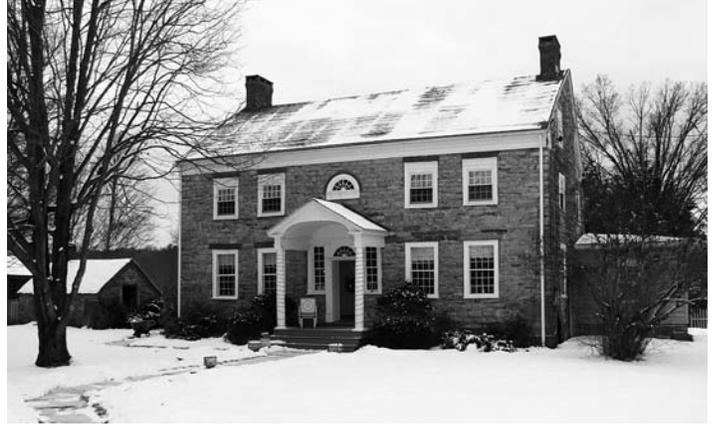
I did receive some leads from another member for the several Myers' houses in the town, which I have yet to follow up on, but there is one Myer house in the village that is documented. At the beginning of Myers Lane is a two story early Georgian, said to be owned by Petrus Myers, built in 1759. Actually it is more like a 1¾ story, as the windows on the second floor are slightly shorter (8 over 8)

The Petrus Myer house of 1759 probably looked much different at first and was "modernized" into a Georgian style about fifty years later without going a full two stories. The fanlight on the second story adds character to the place and helps single it out from all the other Georgian springing up around town at the time.

than on the first floor which are 12 over 12. By my observation, it appears the northeast corner of the house is part of the original smaller house and some fifty or so years later expanded into the Georgian style. A nice feature about this one is the use of the fanlight as the center window on the second floor.

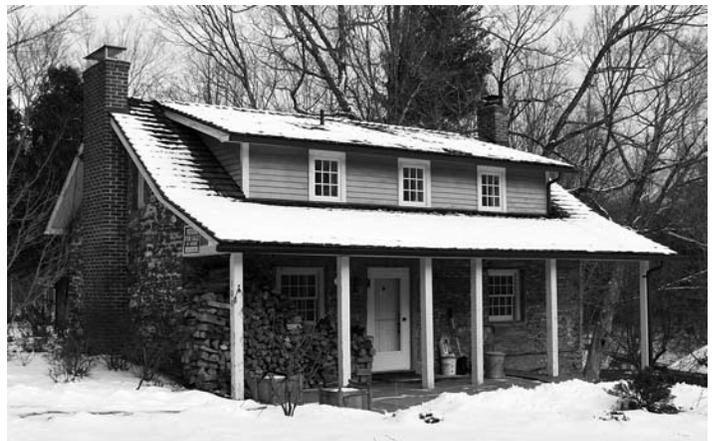
Last time, I wrote how a map can help find old structures, such as an old stone house being on Stonehouse Rd. Same can be true by searching for roads with Palatine names (and Dutch for that matter). For instance, at 100 Ralph Vedder Road in the Blue Mountain area of town, you will find a stone house built by Ralph Vedder in 1743. In January, when I drove past this house there was a "For Sale by Owner" sign in front of it. A quaint looking place overlooking a mountain stream, the exterior features, such as exterior chimneys at both ends and wide dormer with three windows, point to major interior modifications during the last century.

Ralph Vedder's house (1743). The exterior chimneys and dormer across the second story hints to a 20th century total remake of the interior. At the time of the photo (Jan, 2010), the place was for sale by owner. Anyone interested in it enough, could report back what they find on the inside!

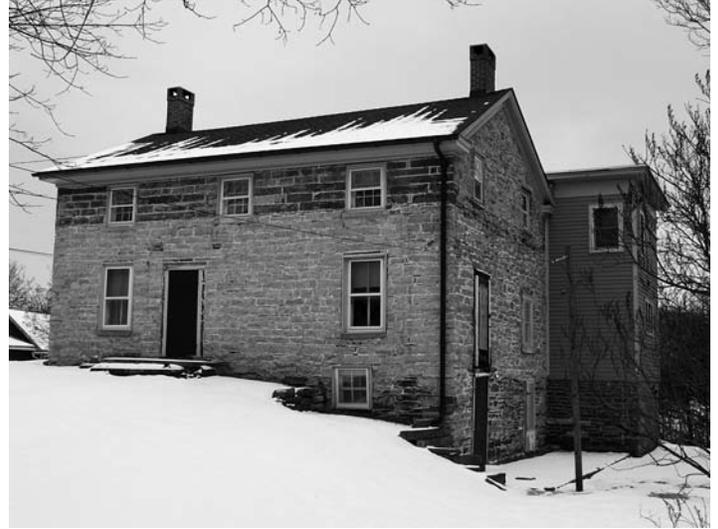
The development of this house at 266 Old Route 32 was definitely in an upwards direction first rather than in the more commonly seen outward expansion. Anyone with information about this place, please drop a line.

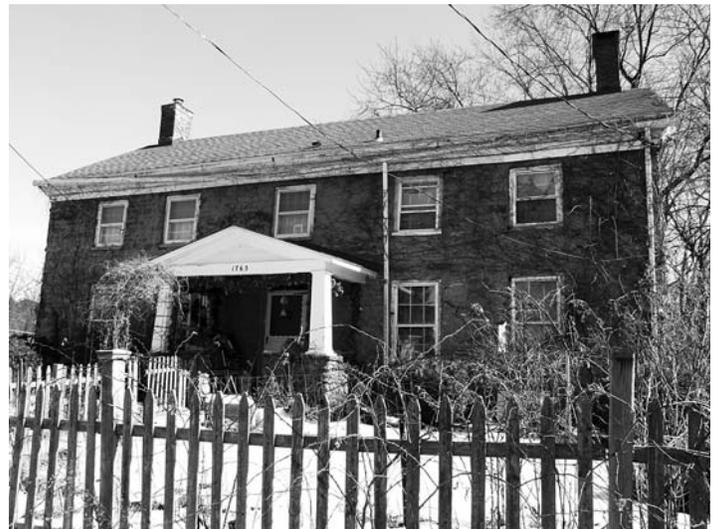
At the corner of Teetsel Street and Ulster Avenue (Rt. 32), is this Georgian style stone house said to be built in 1763. Is this the house of Johannes Myer?

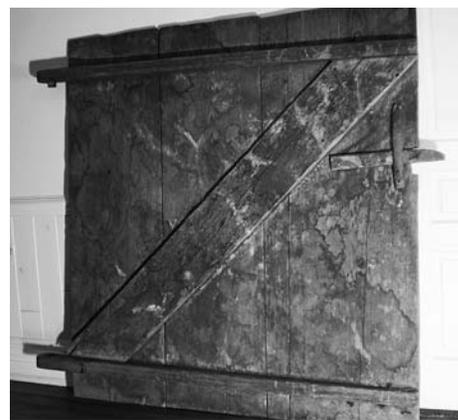
Oliver Barn – Circa 1760

View of one end wall wagon door section – formerly part of Oliver barn on Route 209 in Marletown, Ulster County – showing the door that includes two wooden door hinges, diagonal batten and four front face vertical boards.

The full length of the wooden door hinges are each 5 feet and the extension itself where the wood pintle is engaged is six inches long. The hinges are 3½ inches wide and its corner edges are chamfered. In a perhaps unique expression the door hinges have battens behind them. Pintles are recessed into vertical grooves in the doorposts and this placement is the standard in north-country barns.

Two detached half-wagon door sections (upper and a lower) were found in the early 1990's on the loft of one of the side aisles in the four-bay three-aisle barn at the Oliver homestead off Route 209 in Marletown in Ulster County. The original barn length was of three bays. It is assumed that the doors are original to the barn. It is also assumed that the doors

The one complete half door section in excellent condition appears to be the lower door section due to the location of the wooden door latch. The latch is seen about 3 ½ feet from the bottom of the door and this would seem to be about the right spot for the placement of a latch. This section is just shy of five feet wide by five feet 3½ inches high. Four vertical face boards front the door. Widths of the boards are 19, 18, 4½ and 19¾ inches. All are pine. The boards were never painted.

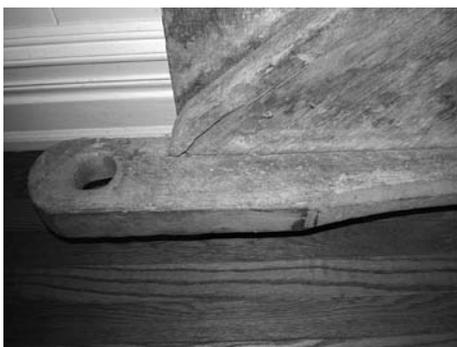
View of one end wall wagon door of Oliver barn that shows flared condition of wooden hinge.

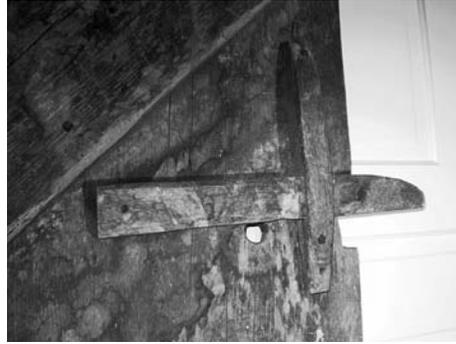
View of two piece door latch of one end wall wagon door section formerly part of Oliver barn. Both wood pieces are oak. Circular finger hole is barely visible below latch.

The door latch consists of two pieces of wood. The vertical oak keep or retainer twelve inches long seems to be original and is secured with two wrought nails. The horizontal (slightly angled) lifter bar is likely original but the nail that attaches it to the door is not wrought and may have been a replacement of the original nail.

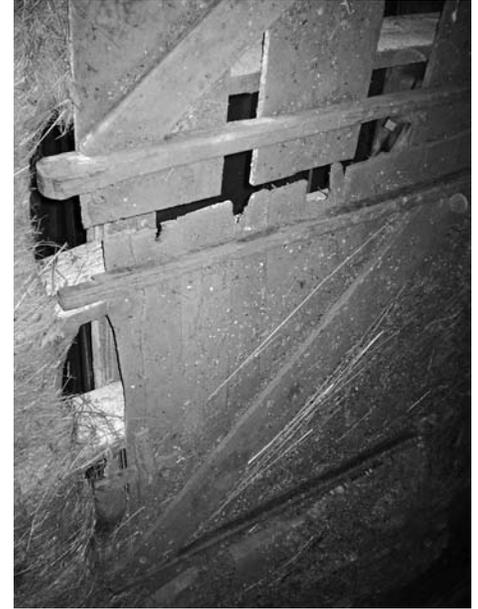
Two end wall wagon door sections seen on loft of dated 1766 Nieuwkirk barn on Hurley Mountain Road west of Kingston in Ulster County. Note original wooden door hinges.

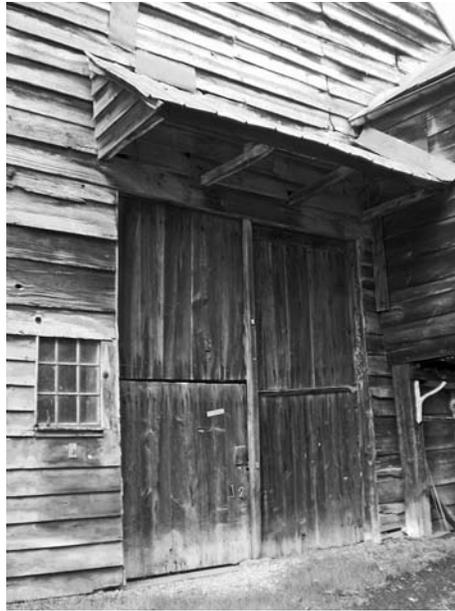
Original end wall wagon doors at the circa 1790 Bogart three-aisle four-bay barn in Marbletown, Ulster County, New York. Doors are in four half sections – two at one side and two at other side. Note mittelmanse at outside of doors. Above doors is partially original pentice.

Unlike the Mahoney barn that retains its original pentice the Bogart barn has almost all its original weather-boarding on the end wall where the authentic wagon doors are positioned. It is clearly seen that an original board covers the end wall anchor-beam from which the pentice arms are in contact. It can only be assumed that this case of original boards covering end wall anchor-beams prevailed at other barns. This condition appears to be the situation at the Wemple barn.

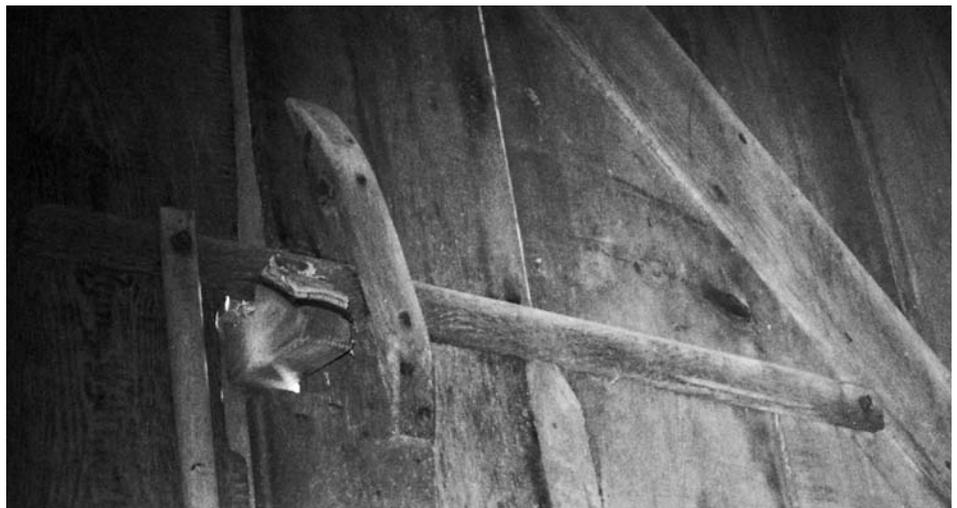
Interior of original end wall wagon doors at the Bogart barn with close-up view of unusual four piece all wood door latch release mechanism. Door was unlatched in interior of barn.

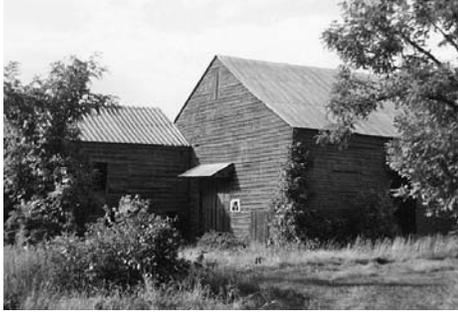
DuBois probable three-bay three-aisle barn that was formerly located on Libertyville Road near New Paltz in Ulster County. This barn had both an end wall wagon door with wooden hinges and perhaps uniquely a side wall wagon entrance with wooden hinges.

A three-aisle barn of probable three-bay construction was located on the west side of Libertyville Road (Albany Post Road) southwest of New Paltz in Ulster County. It burned to the ground on the night of June 1, 1977. It stood immediately across the road from the dated 1822 brick two-story DuBois house. Many photos

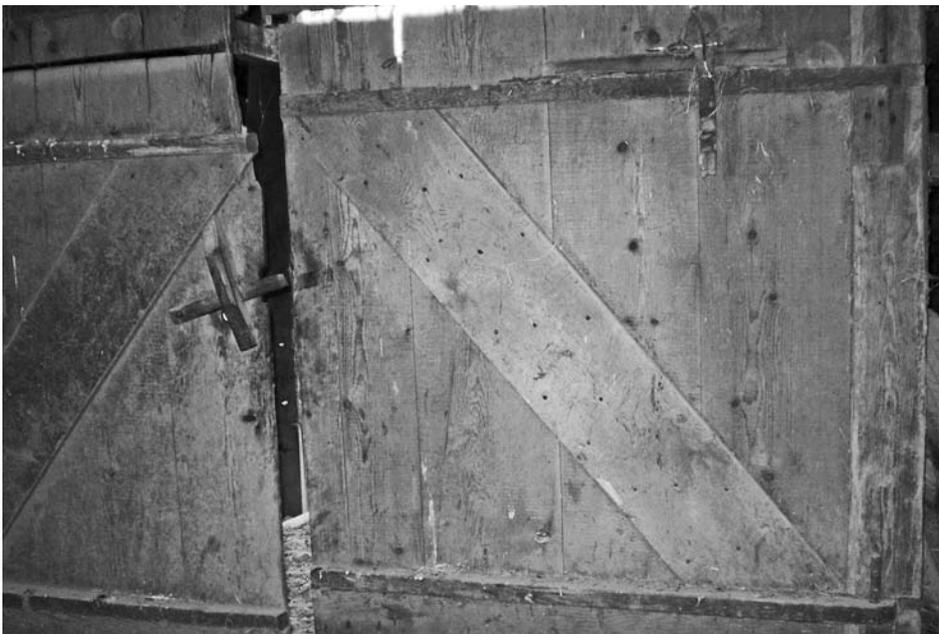
John Snyder Barn – Circa 1820

Interior of John Snyder circa 1820 side entrance Dutch-Anglo barn on Route 212 west of Saugerties in Ulster County. View is shown of two lower half door sections with wooden hinges. On left door is two-piece door latch.

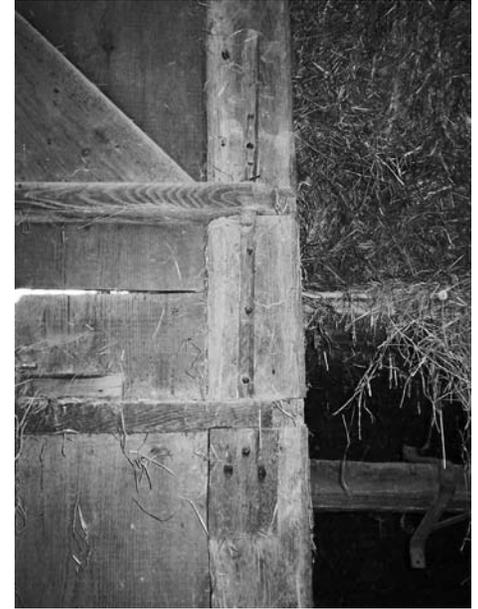
Interior of John Snyder barn and view of very long single piece wood pintle at right side of door opening that secures one wooden hinge of each of two half door sections.

As often seen in typical Ulster County tradition the wood pintles sit on top of the door posts. Pintles are oak and five of the eight are original. Unlike anything seen in the north-country the bottoms of the pintles are widened and have a plate like

aspect – they are three inches in height and vary in their widths – five to seven inches. Ken Snyder the owner replaced one of the original pintles in the 1990s that was patterned after the original where oak was used.

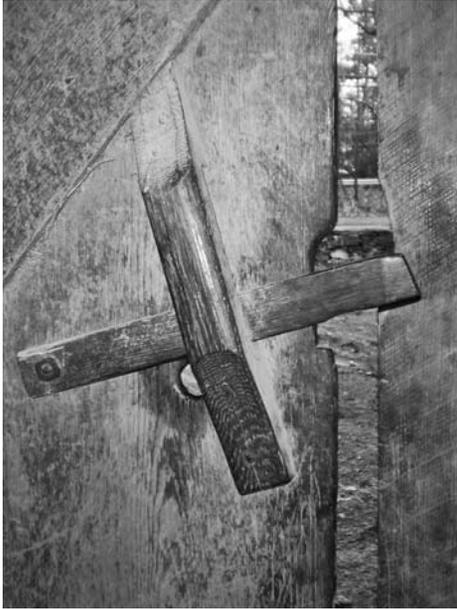
Close up of two-piece all wood door-latch in interior placed wagon doors seen in John Snyder side wall entry barn. Note quite severe angle of door-latch keep.

side wall. Each door is 5 feet high and 4½ feet wide (left side) and four feet four inches wide (right side). The left door has four front face vertical boards and right door has seven front face vertical boards. The door latch has a two-foot long lifter bar. The doors opened inwardly.

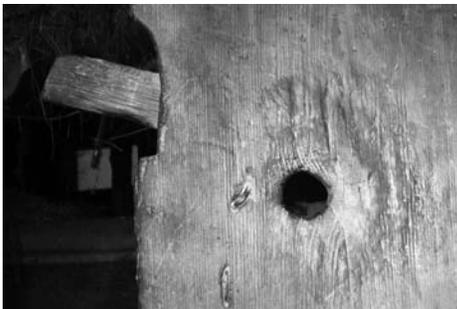
Interior of John Snyder barn with close-up shown of circular finger hole in lower wagon door section. Finger was inserted into hole to free latch of door.

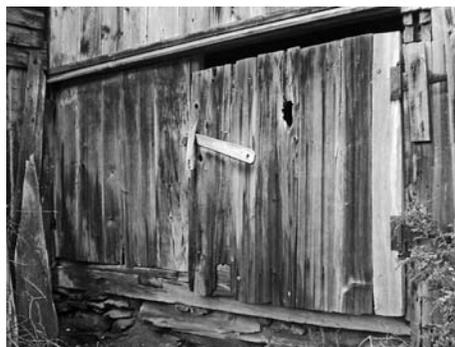
Wagon doors seen at the Hopper-Goetschuis Museum barn in Saddle River, Bergen County, New Jersey. These re-cycled doors were found at a former site in a side entry Dutch-Anglo barn that stood on another road in town.

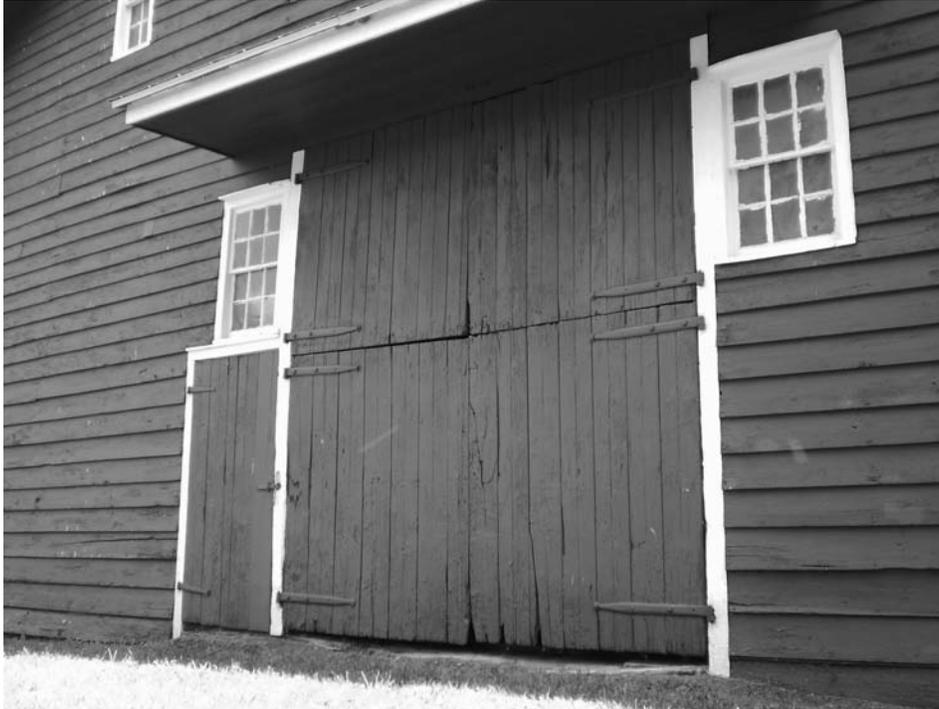
Short height side wall frame constructed doors at Vinicor barn on Wittenberg Road west of Bearsville in northern Ulster County. Doors may have allowed sheep or other short farm stock into barn.

The Vinacor barn is a four-bay one-aisle structure and it appears on the north side of the Wittenberg – Bearsville road southwest of Bearsville in northern Ulster County. A carved date appears on the side wall doors and it seems to be in the 1830's. The doors discussed here may not be wagon doors at all as only two or side by side half height doors appear on the

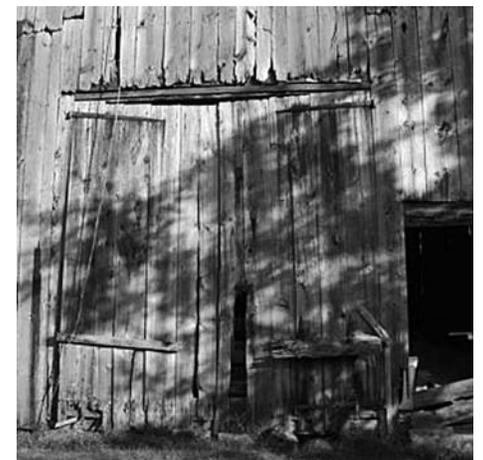
View of original end wall upper wagon door section at north side of door opening at the dated 1851 Elmendorph variant U-barn on route 213 near High Falls in Ulster County. Wagon door has two upper and two lower door sections and doors swing outwardly.

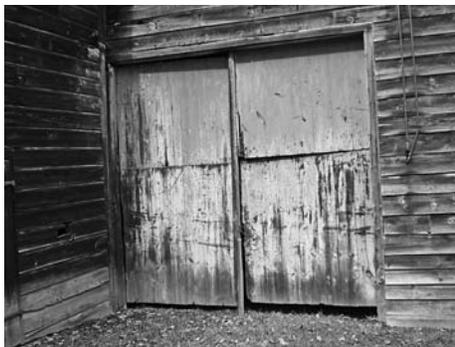
Replacement wagon doors at the Oliver 3-aisle barn in Marletown in Ulster County on south side of Route 209. Wagon doors are in four parts – two sections at left and two sections at right side. Doors swing inwardly that is likely not common for replacement doors in barns.

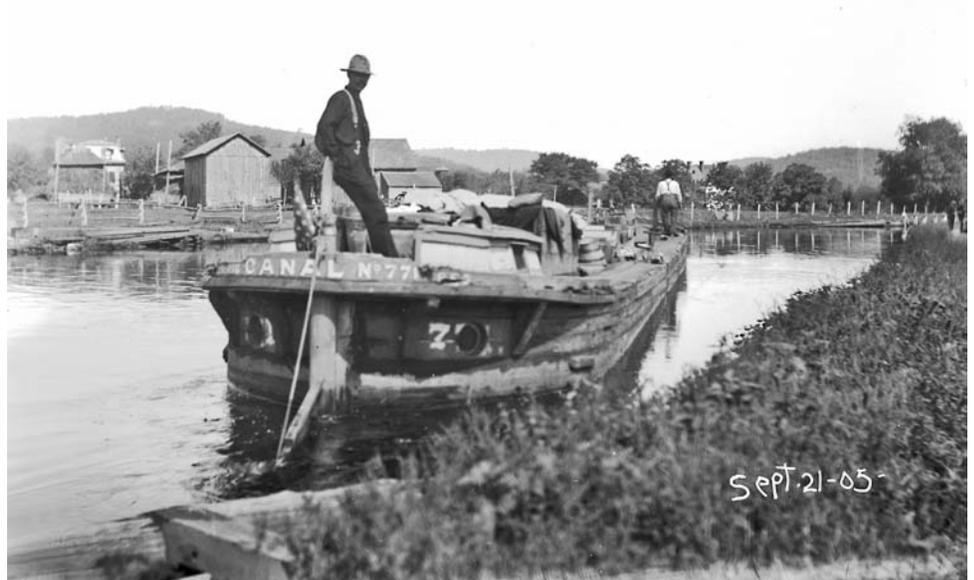
In this photograph is the Morris Canal - between Plane 8 in the Montville Village area (New Jersey) – south of Route 202. Looking carefully you can clearly discern two hay barracks, they are located in back of the Gladson house – which at the time of this Photograph (1905) was known as the Kayharts. Photographer: Olin F. Vought.
