Barn 1: Hamilton Tract Lot #28 Tenant barn (Holland Township barn survey #1) 1787

Ground level, three-bay swing beam barn. Ground level 3-bay, swing beam barns represent the oldest remaining barn type in Holland Township. This barn is an excellent example of its type and is the oldest dated barn in the township. The associated farm was a tenant farm within the Hamilton Tract until 1813 when it was sold to William Miner. Its 1787 construction date suggests that the barn was built by the tenant who leased the farm.

Barn 2: Holland Township Barn Survey #2 1793/4
642-643 Milford-Mt Pleasant

Barn 3: Philip Burgstresser Barn (Holland Township barn survey # 21) circa 1820
210 Church Road

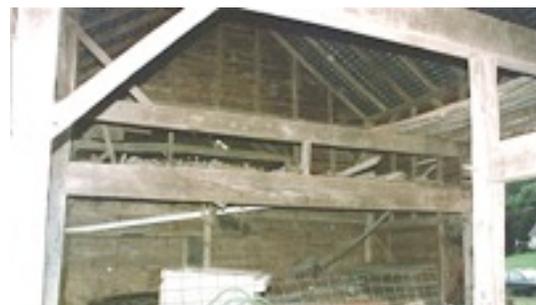
Photo from 2001 showing loft

As with all of the ground-level 3-bay, swing beam barns, in Holland Township, this barn has a side entry plan. North and south wagon doors lead to the center bay that was flanked by animal stables on the west and a swing beam which expanded the threshing floor to the east (based on evidence). A hay loft occupied the east bay above the threshing floor and a straw loft occupied the north end of the center bay (undressed sapling poles remained when first investigated in 2001).

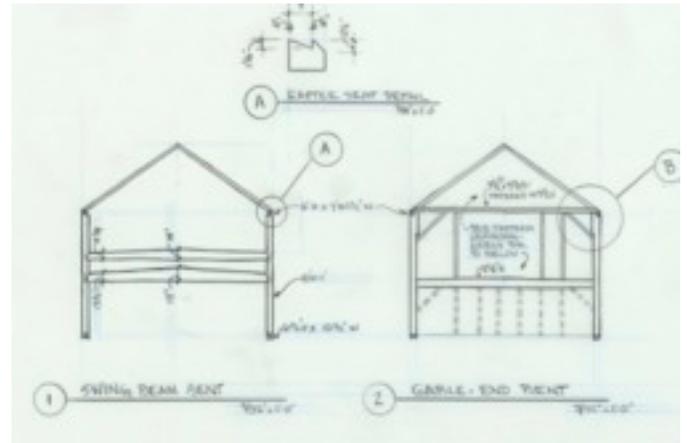
Ground level, three-bay swing beam barn. This barn is the second oldest dated barn in the township. It is similar to the tenant barn except the gable end bents have gunstock posts that support a traditional English tying joint instead of the Americanized method of framing the upper tie beams into the posts. The farm on which the barn stands was sold in 1765 and therefore this barn was probably not built by a tenant farmer. The presence of a traditional English tying joint in a swing beam barn that also has dropped tie beams in the interior bents, shows the melding of ethnic traditions and the Americanization of framing methodologies.

Characteristics:

- Bents are framed with two full-width, cambered tie beams in each bent with no intermediate posts
- Entirely hewn oak including major components and all remaining original braces, studs and rafters

- Hefty posts with the widest dimension oriented parallel to the ridge
- The four corner posts are gunstock posts (11" deep x 10" wide) and (13½" deep x 10" wide at the flair).

- Double notched rafter seats (all of the ground barns dated after 1800 have single notch seats)
- Hewn oak cambered swing beam (13½" (h) x 9½" (w) at each end 19" (h) x 9½" (w) at the center). Chamfer on the edge that faces the threshing floor. Not joined to the upper tiebeam.

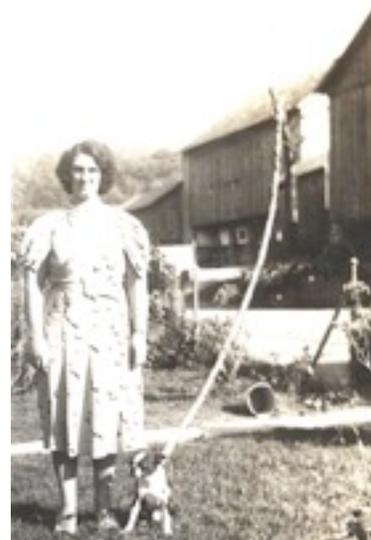
Stone Standard Pennsylvania forebay with a light Germanic frame

This two-level stone bank barn was “far superior” in both form and framing. The lower level offered a space to stable livestock and the forebay sheltered the stable doors. The upper level allowed for crop storage. This barn type began in Lancaster Co. Pa and migrated northeastward. Perhaps unknown to Jesse Sinclair, its German framing was also very different from the heavy timber swing beam frames of the smaller ground-level barns. Both the Burgstresser barn and the Fine barn are engineered with lightly framed bents composed of a large number of smaller timbers and spaced further apart.

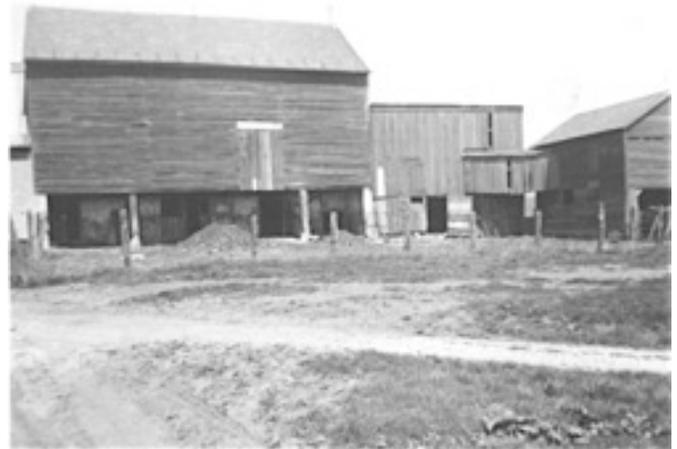
Frame Standard Pennsylvania Forebay with a heavy timber swing beam frame.

Jacob Bunn purchased this farm in 1806 but did not construct the existing bank barn until 1820-21 suggesting an earlier barn once existed on the property. Jacob Bunn had been a tenant under the proprietary land ownership of James Hamilton and is believed descended from Matthew Bunn, a Quaker who settled in Woodbridge, NJ in 1670. This barn is of extreme importance to the understanding of barn construction in Holland Township. Bunn evidently copied the forebay banked form from the German settlers in the western mountainous section of the township but utilized the heavy timber swing beam framing methodology of the ground-level, swing beam barns. This suggests that Bunn hired a local framer who copied the external barn form but who evidently did not understand or did not know about the lighter Germanic framing techniques. The framing characteristics of this barn are very similar to that of a ground-level, four-bay swing beam barn.

Characteristics:

- 7'-9" (+/-) deep forebay supported by two posts (reconfigured for dairy cows)
- The stable wall was stone and had three split doors and one paired hinged door opening into the basement level

- Two full-width cambered tie beams in each bent except the bent between the haymows which has one tiebeam
- Hewn oak and chestnut major components (fast grown), sawn oak braces and studs
- Hewn oak studs reused in the ell and the basement.
- Tapered, hewn oak rafters were reused as ceiling beams in the granary
- Scribe rule with 2-foot scribe marks noted and very faint marriage marks.
- The upper tie beams are 5'-7" below the tops of the end posts in the interior bents flanking the threshing floor
- The tie beam is 9'-7" below the tops of the end posts at the bent between the haymows.
- Hefty posts with the wider side parallel to the ridge.
- Raising holes on all posts.
- Hewn oak swing beam 11½" x 7" at each end, 16" x 7" in the center joined to the upper tiebeam with a strut and passing braces.
- All of the tie beams are cambered
- Diminished shoulders
- Through tenons
