HVVA tour of Rensselaer County: The tying joint in Pittstown and Hoosick.
19 May 2012

Introduction

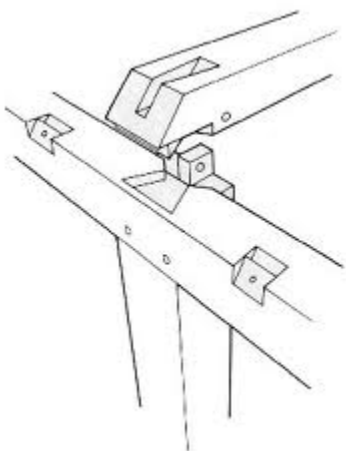
Figure 1. The three-part tying joint, seen from outside, and above.

The three-part tying joint is a connection in which the top plate of a wall, the tie beam, and wall post all intersect in one sophisticated joint. This form of joinery is much more complex than framers who used the New World Dutch system of framing engaged in, and when done well is a thing of beauty (Figure 1). The posts in this framing system are frequently flared toward the interior at the point of juncture with the other two framing members; this facilitated the fabrication of the joint without requiring that the entire post be of massive size.

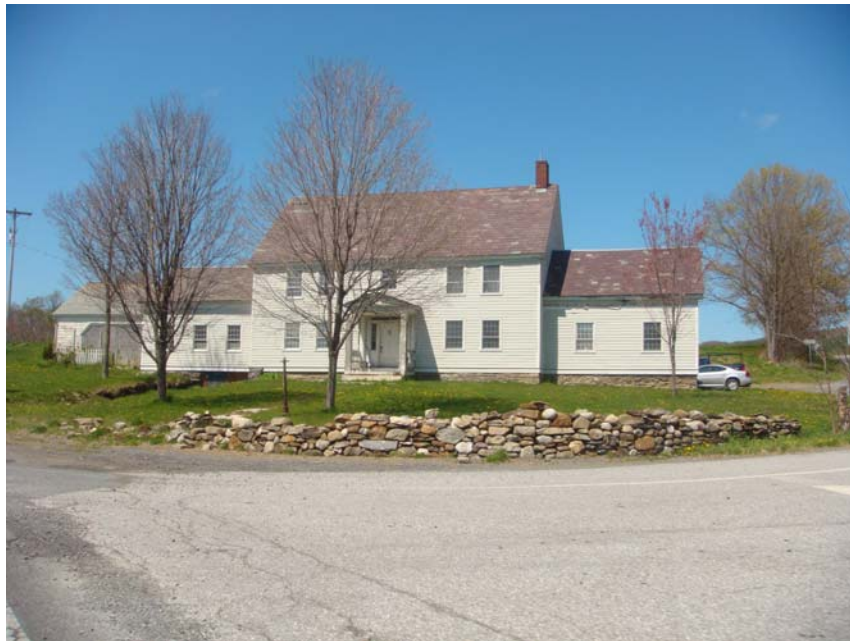
Figure 2. The Hills house, Coila Vicinity, Town of Jackson, Washington County (all pics by W. R. Wheeler unless noted otherwise).

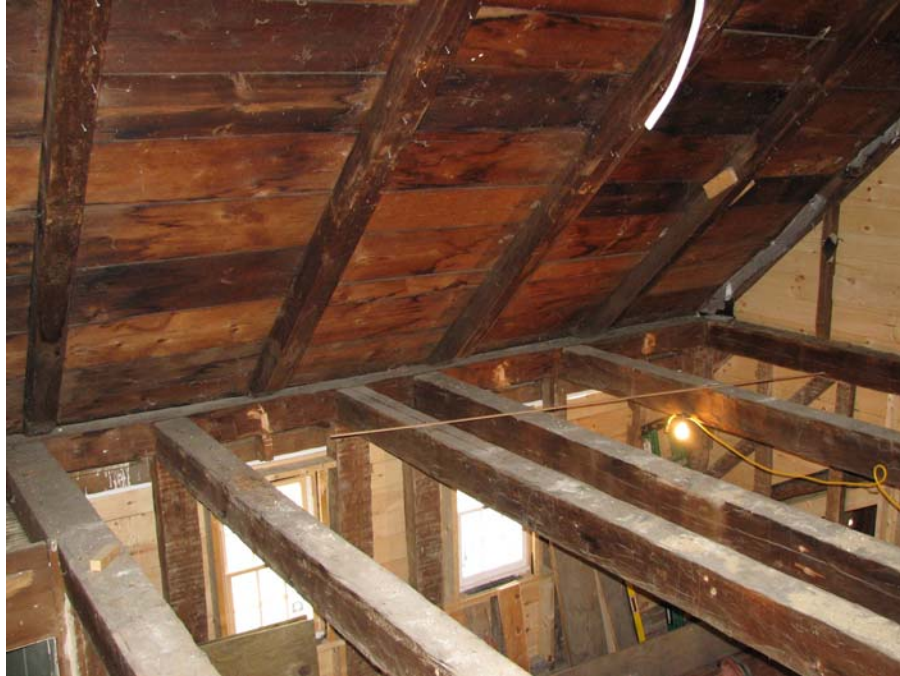
Figure 3. View in the attic of the Hills house, looking at the tops of six of the tying joints—from among 24 used in the main house and almost 30 more used in the two wings. In this one example, the use of “gunstock posts” was eschewed so that the posts could be concealed within plastered walls.

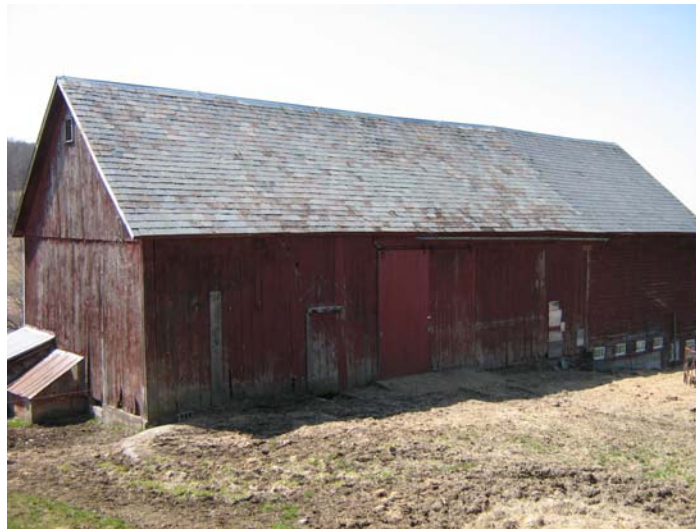
Figure 4. View of the three-bay threshing barn, with later one-bay addition to the right, on the O’Donnell Hill farm, Town of Jackson.

Another example in the Town of Jackson, on the O’Donnell Hill farm, also visited as part of our tour of Washington County in August 2010, is a three-bay threshing barn which features the three-part tying joint associated with pocketed braces (Figures 4 and 5).

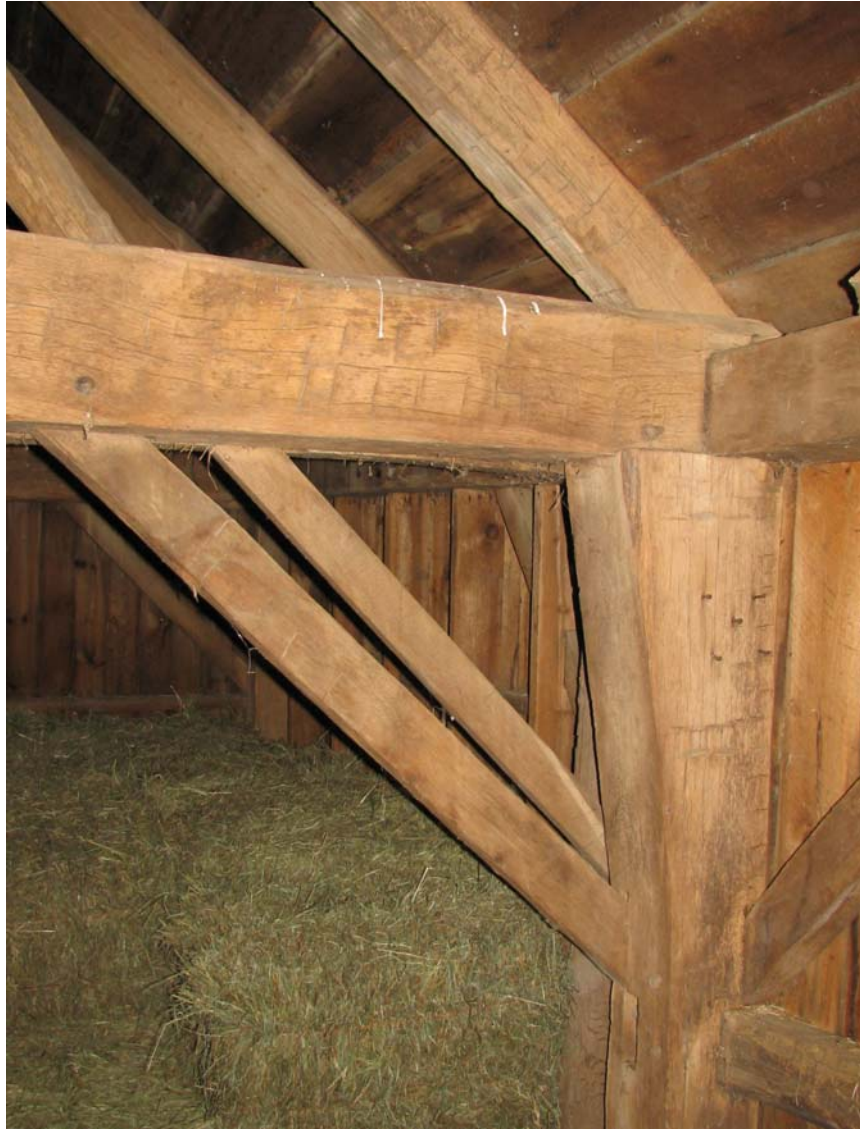
Figure 5. Typical joint in the O'Donnell Hill barn. The flared top of the "gunstock" post is particularly evident in this shot.

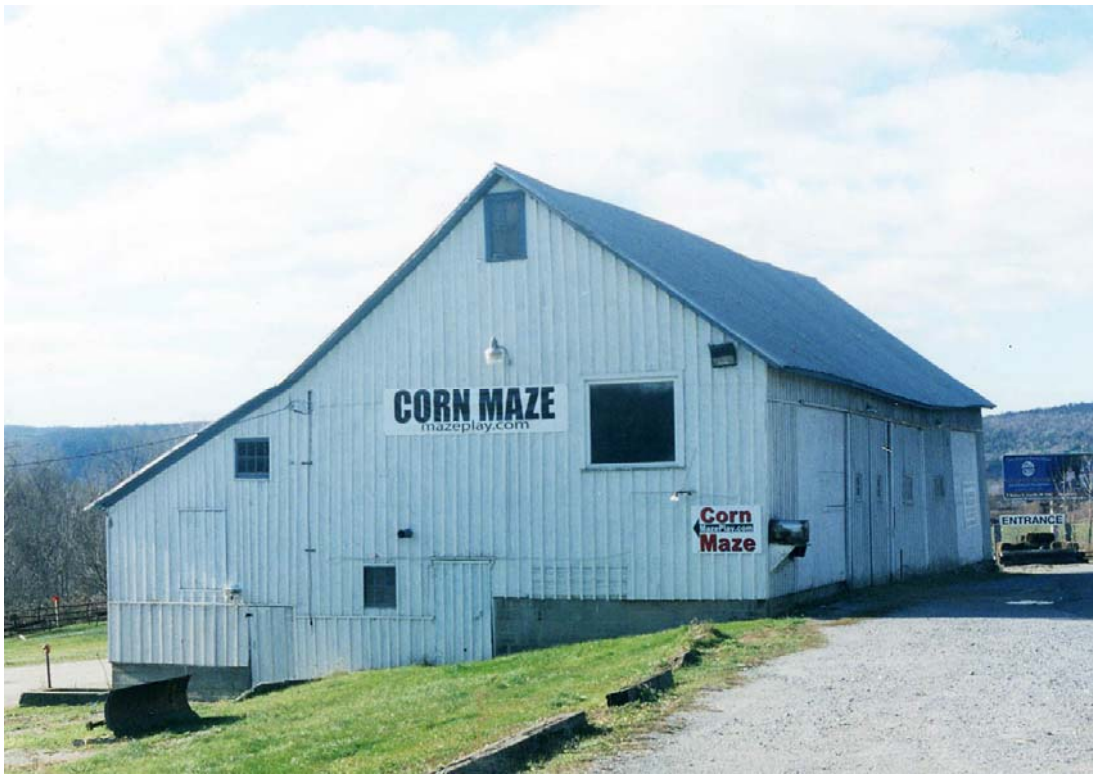
Figure 6. View of the threshing barn (Connie Kheel photo).

The Morgans own two photos of cavalry encampment on the farm of the 15th US Cavalry (dated 1906 & 1907). The photos show the English barn as well as a couple of barns that no longer exist. Next door to their home and restaurant is the English tie beam barn, the oldest known barn in Hoosick and an unusually large English tie beam barn (Approx. 74 ft. X 30 ft.). Behind the English barn is a later period timber framed structure.

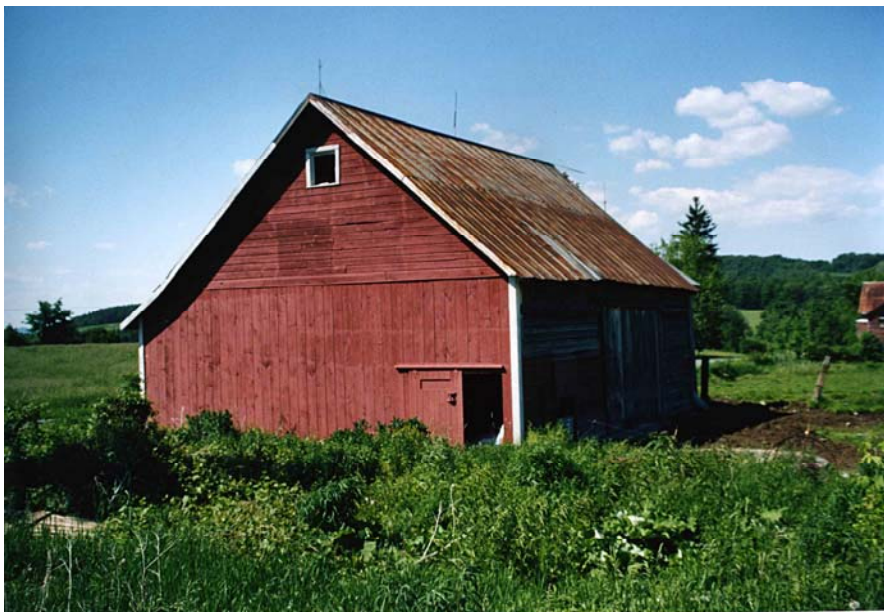
Figure 8. The Cipperly (Siemens farm) barn (Connie Kheel photo).

Carl Cipperly's English tie beam barn is on what he calls the Siemens farm. It is a property that Carl's family purchased close to 50 years ago to expand their dairy operation. It's now used for hay storage and livestock shelter. The farmhouse which went with the barn is located a small distance away and is still owned by the Siemens family. Carl's farm is about a half mile from the English tie beam barn. Carl will be able to talk about how the barn was used or was altered over the years.

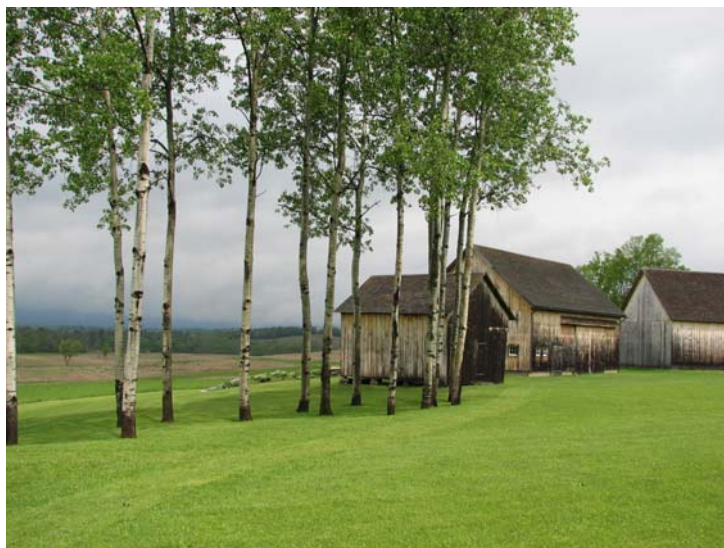
Figure 10. General view at Nipmoose, with the corn crib and two barns.

Nipmoose is owned and operated by The Persistence Foundation (<http://persistencefoundation.org>), a not-for-profit 501(c)3 established in 1996, “dedicated to the dual mission of conserving agricultural lands and preserving agricultural heritage.” The Nipmoose site includes a group of outbuildings: two very interesting barns—one of which features a variation on the tying joint in its construction (the “gunstock” posts being turned to be in-line with the exterior walls)—a corn crib and a bent-framed house (currently stripped to its frame on the interior), plus some of the best views this side of heaven!

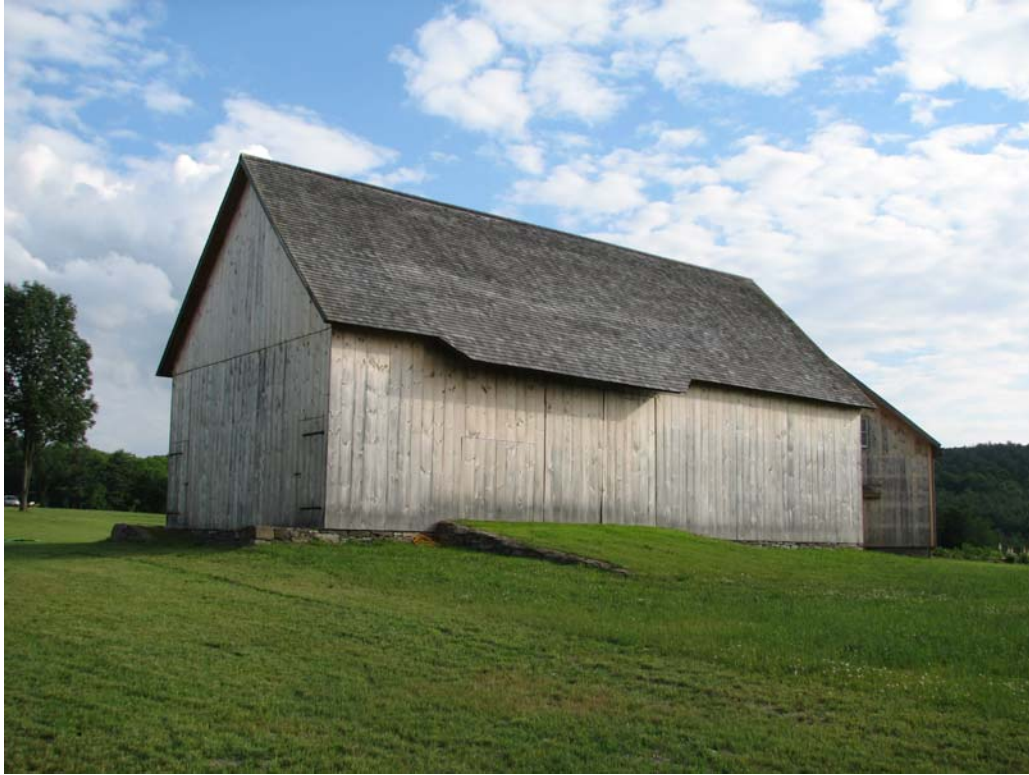
Figure 11. View of the tying joint barn at Nipmoose.

- Sill:** 9 in. wide x 9 in. deep
- Stonewall Foundation:** 2 ft. high x 2 ft. deep
- Tapered Post:** Width 9 in.–11 in. (base and top); depth ranges from 12 in.–14 in. at base and 18 in.–19 in. at top
- Thatch Pole:** 2 in. wide x 2 in. deep
- Tie Beam:** 13 in. wide x 10 in. deep

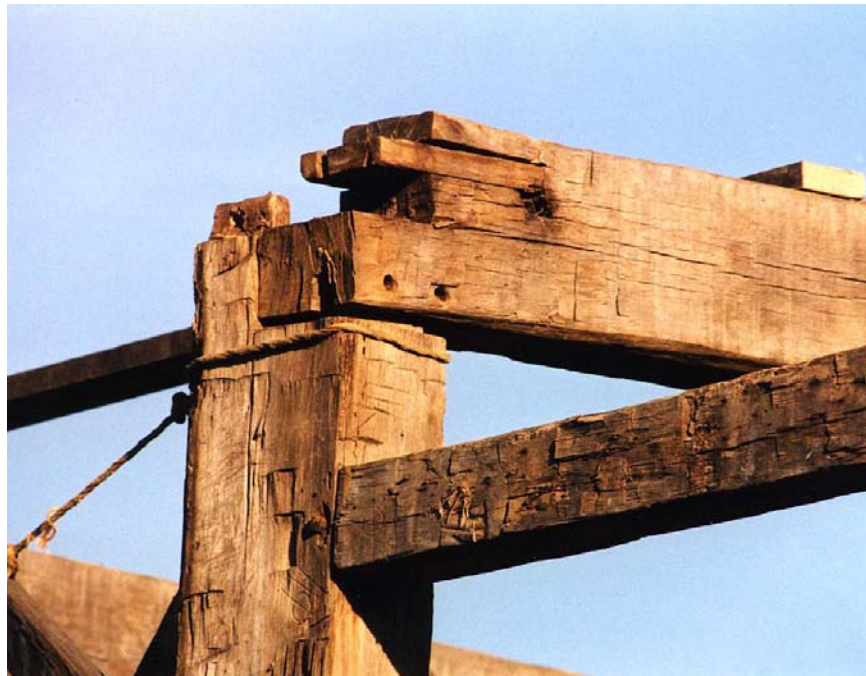
Figure 12. View of a typical joint during the restoration of the barn. Note the marriage marks incorporating a circle and slashes of the race knife, just below the lower part of the joint (Photo courtesy Connie Kheel).

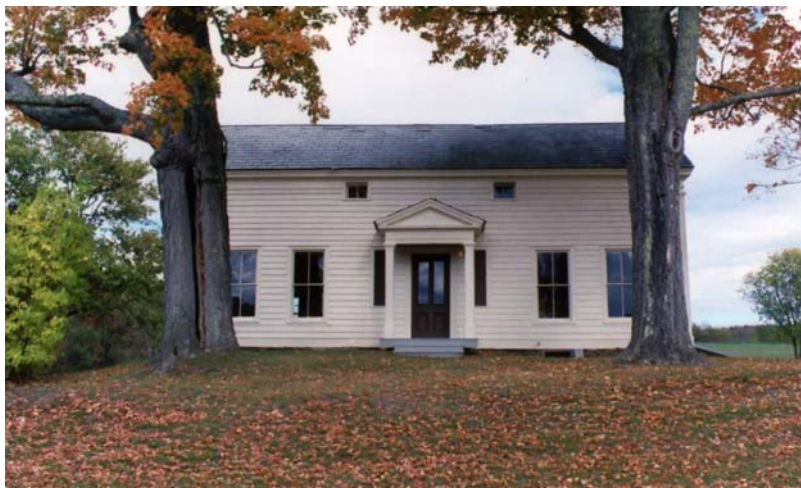
Figure 15. The house at Nipmose farm. Probably dating to the early 19th century, this house makes use of bent framing in its construction (Connie Kheel photo).
