**Dendrochronology of the Wixson Road Log Cabin and Benjamin Patterson Inn,
Corning-Painted Post Historical Society, Corning, NY**

Carol B. Griggs
NE North America Dendrochronology Project
Cornell Tree Ring Laboratory
Cornell University
Ithaca, NY 14853
E-mail: cbg4@cornell.edu

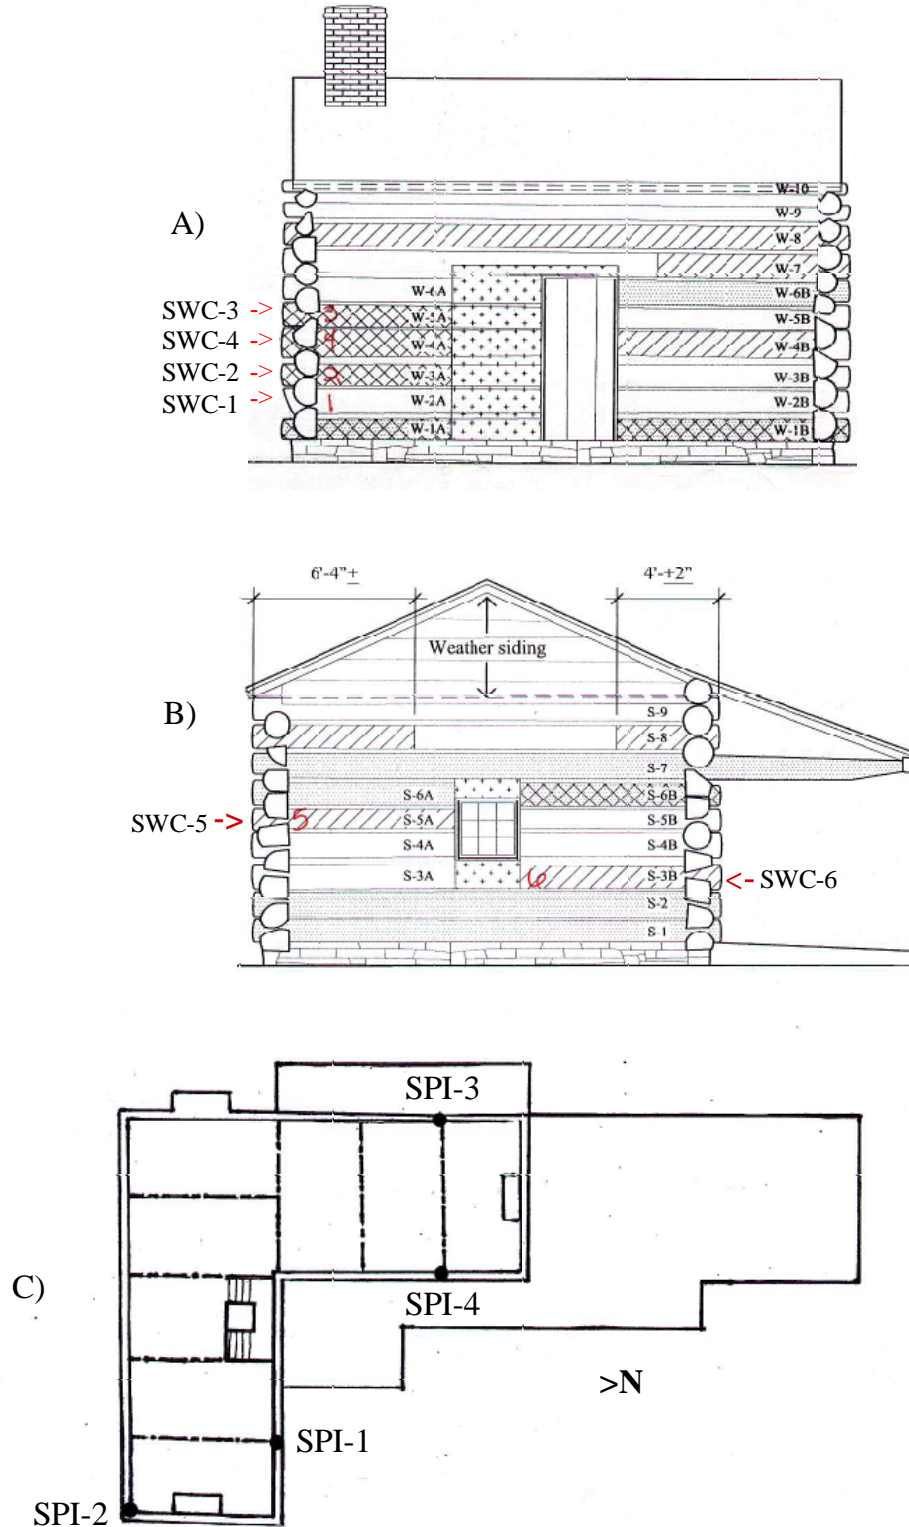
Figure 1. A) and B) The west and south exterior walls of the Wixson Road log cabin, indicating the logs that were cored. C) The attic floor plan of the Benjamin Patterson Inn, indicating the posts that were cored.

Six cores from six logs on two sides of the Wixson Road Log Cabin (Figures 1A and 1B) and four cores from the top of four posts in the outer walls of the Benjamin Patterson Inn (Figure 1C) were collected by Pamela Sullivan, Carol and Katie Griggs in May 2003. The cores, 1 cm in diameter, were drilled out with increment borers and the holes filled with dowels, colored to blend with the surface of the surrounding wood. All are of oak (*Quercus* sp.). The cores were measured at the Malcolm and Carolyn Wiener Laboratory for Aegean and Near Eastern Dendrochronology at Cornell University (see Table 1).

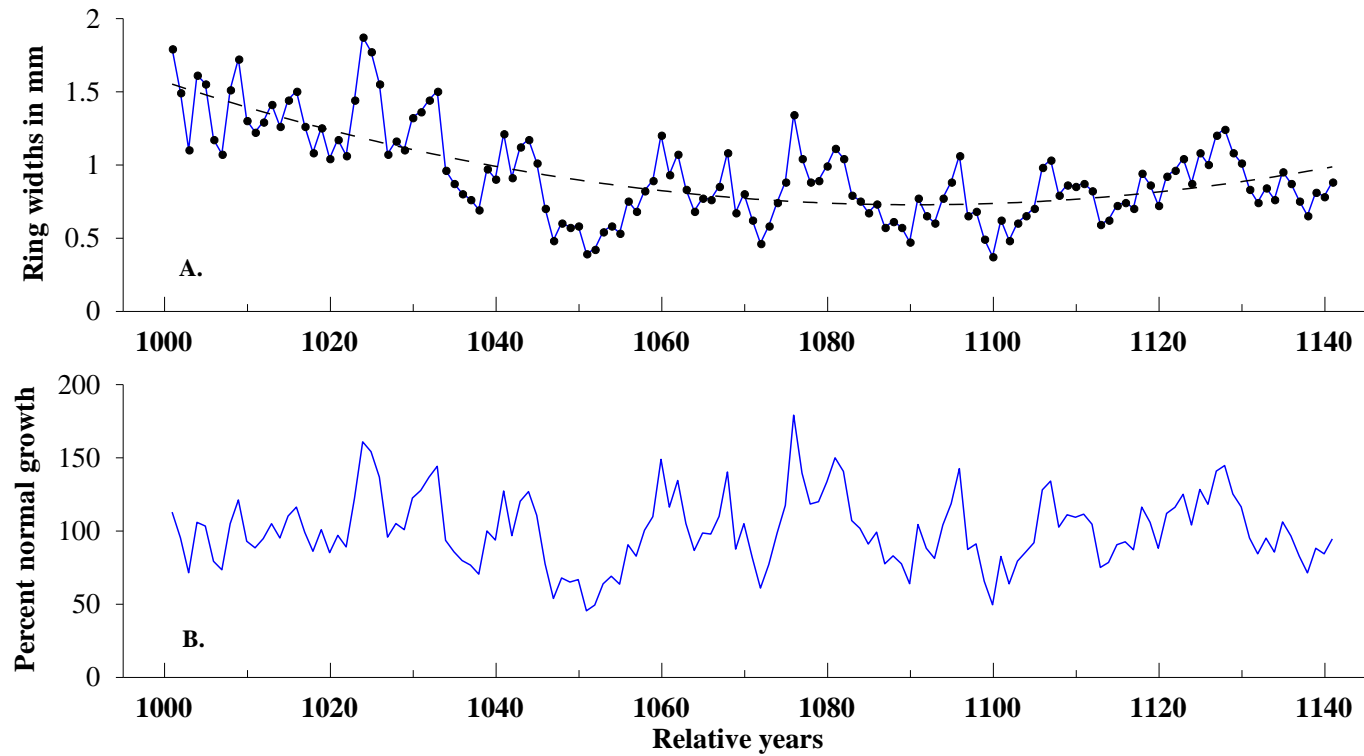
Figure 2. A. The annual raw width measurements of SWC-4, connected, and a line fitted to the data. B. The standardized data, using the fitted line as “100% normal growth,” and dividing each ring measurement by the value of the fitted line at the same year. The standardized data is the norm for looking for similar patterns in ring growth between two or more trees.

Using techniques for standardizing dendrochronological data, a curve was fitted to each sample's ring measurements (Figure 2a). That curve was used as the "100% normal growth" line, and the measurements were divided by the curve's corresponding values (Figure 2b). This is a common technique used so that the comparison and crossdating of samples are not hampered by differences in ring-widths over the trees' lifetimes and in the rings' average sizes.

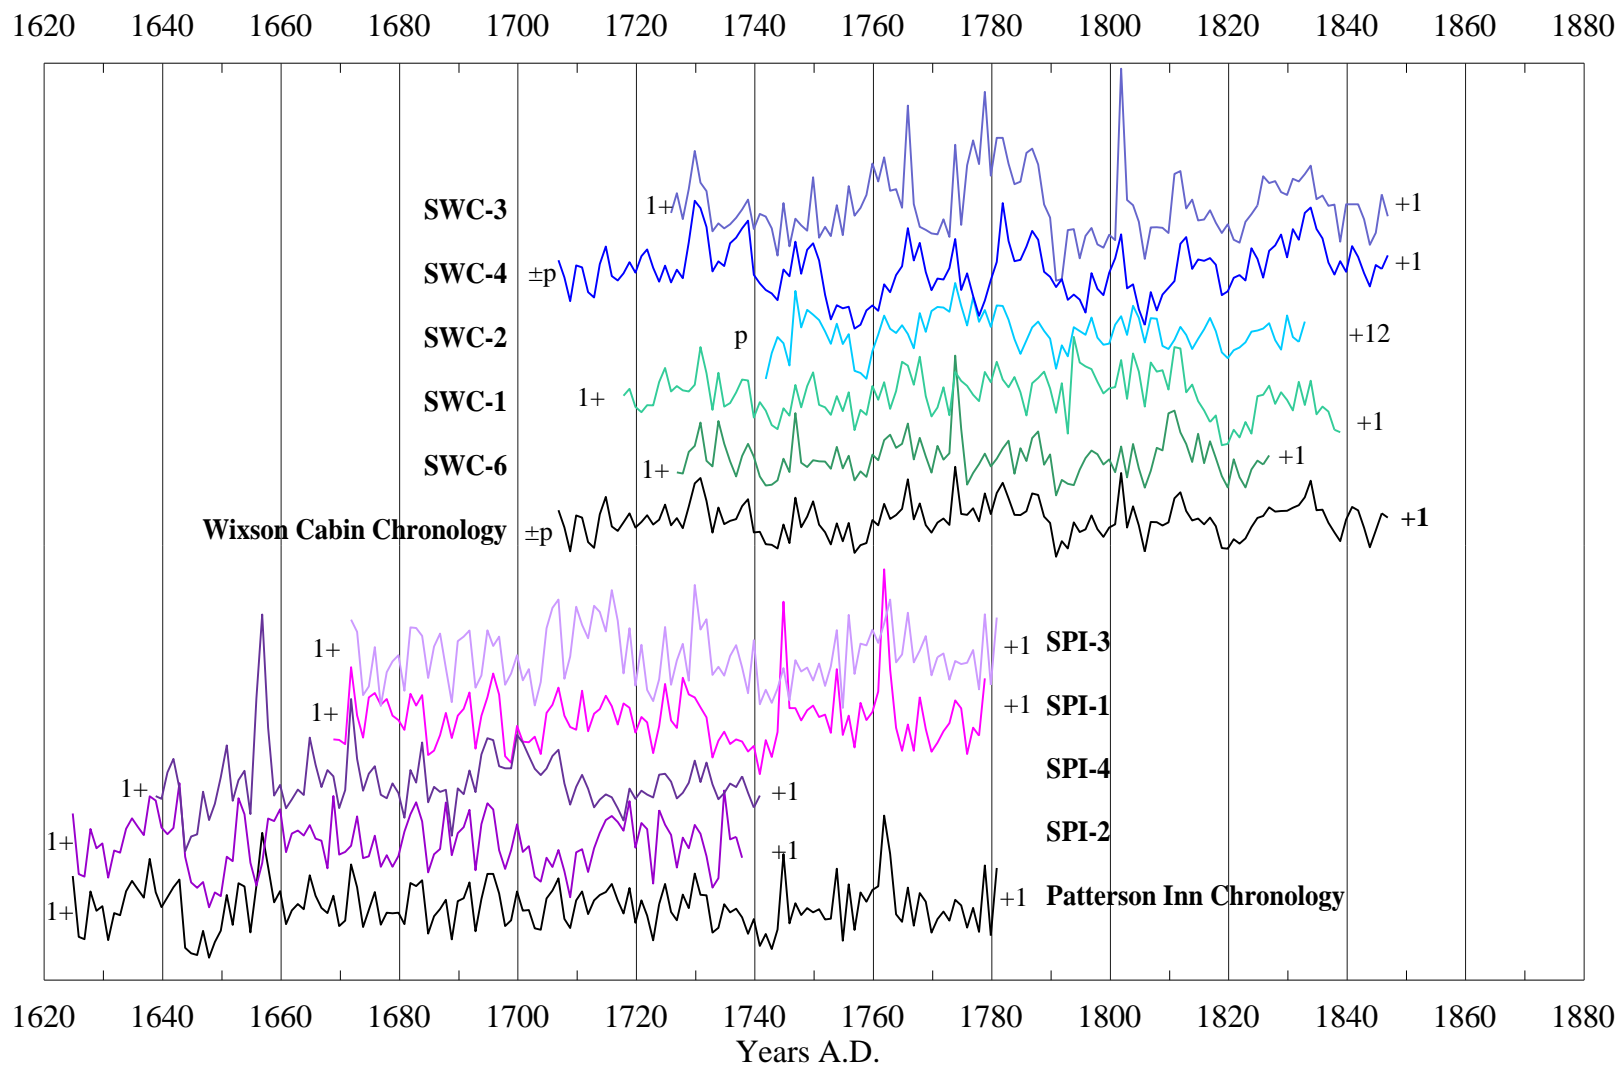
Figure 3. The Wixson Road Log Cabin and Benjamin Patterson Inn chronologies with their samples.

The samples’ data were then compared and crossdated, looking for matching patterns in ring growth. Figure 3 shows the single samples along with the chronologies combining each building’s samples. Note the similarities in the year-to-year variations in ring size: the same increase or decrease occurred from one year to the next: that is the most important pattern similarity for securely dating tree-ring sequences. The second pattern similarities that are examined are not year-to-year differences, but similarities over longer sequences of time, when the rings were generally wider or thinner. Another emphasis in crossdating is on the narrower rings, mainly the results of the same stress to all the trees. The very wide rings are commonly due to individual tree growth caused by a close branch or repair to some local damage to the cambium. The trees of the Patterson Inn are very similar, both in year-to-year change and long-term change. The trees used in construction of the Wixson Road Log Cabin chronology have more differences between the trees, perhaps due to a more diverse environment. Table 2 contains a list of the two chronologies and their dates.

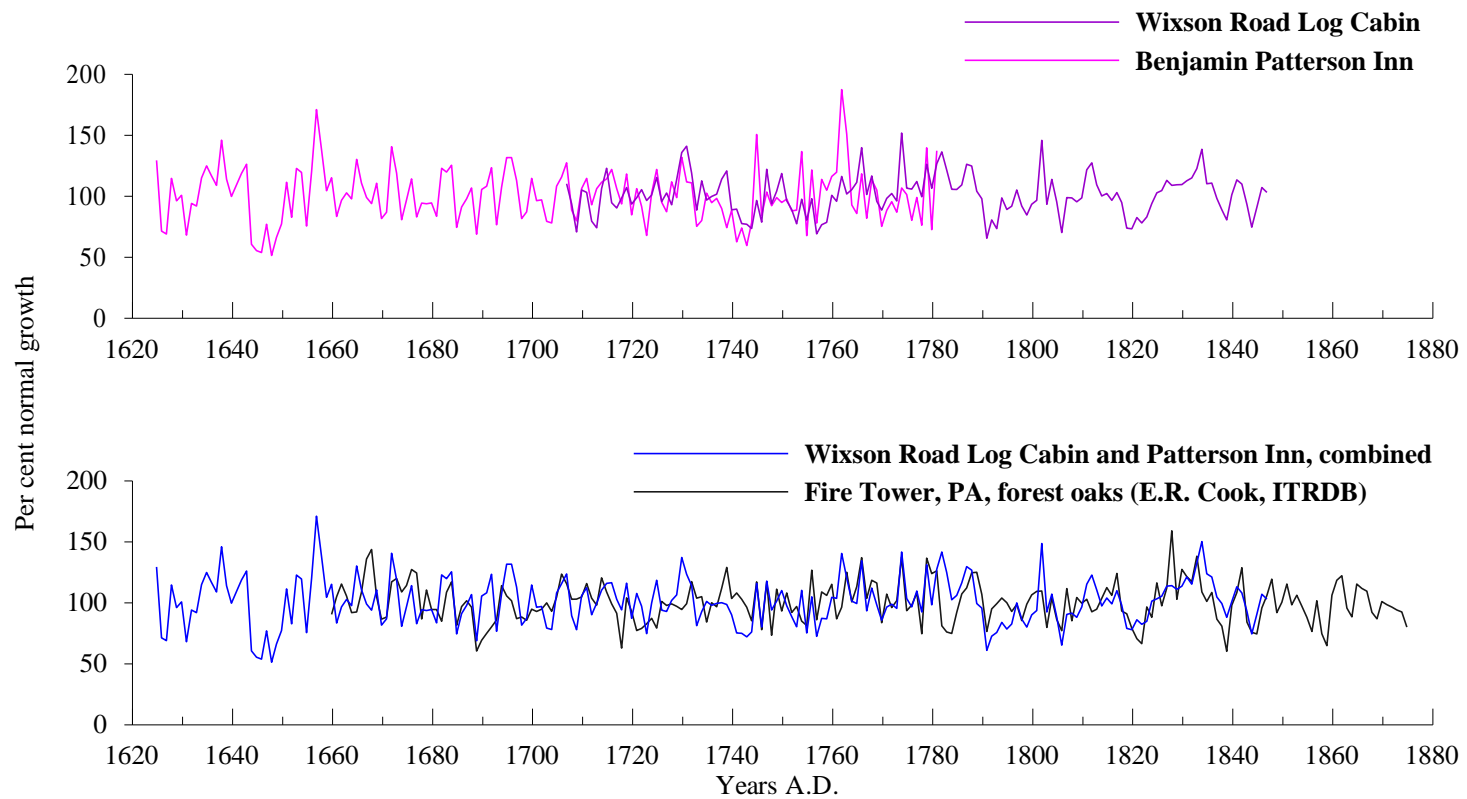
Figure 4. A) The two building chronologies. Note how the patterns are similar, especially year-to-year change in per cent normal ring growth. B) The combined building chronologies and the modern Fire Tower, PA, white oak chronology, truncated at 1875. Again, note the similar patterns in the two chronologies.

The cabin chronology crossdates very well with the inn chronology, as shown in Figure 4A, overlapping by 75 years. Again, note the similarities in both year-to-year and long-term time frames. They are not exactly the same, but securely crossdate because of the number of years where they are very similar. Statistical analysis indicates that the two chronologies have a Student's *t*-score of 5.28, much higher than any *t*-score with the chronologies at any other overlap, and that 68% of the year-to-year changes are the same. They end 66 years apart, with end dates of 1782 for the inn and 1848 for the cabin chronologies.

Figure 4B shows how the absolute calendar dates were determined for the combined building chronologies, thus each building chronology and their samples. The modern chronology of oaks used for establishing all the calendar dates is composed of 28 cores from 14 white oaks in Fire Tower, PA, at 41.19N, 79.13W, approximately 150 km southwest of Corning. The cores were collected by E.R. Cook, and the data is available on the website <http://www.ngdc.noaa.gov/paleo/ftp-treering.html> from the International Tree-Ring Data Bank. Again, there are many similarities in the year-to-year and long-term variations in the two chronologies: an excellent visual fit. Their Student's *t*-score is 6.58, and 63% of year-to-year changes are the same for the 188 years of overlap. Thus we are able to accurately date the samples, the building chronologies, and the combined chronology as listed in the tables. One exciting aspect of the Patterson Inn chronology is that the first whole ring dates to 1625, before the Fire Tower data beginning in 1660, so the available oak tree-ring data now extends back to AD 1625 for this region.
