Sunday, February 5 A small group met at the Squire Nicoll House in New Windsor, Orange County, on the north bank of the Murderer's Creek. This house was recently purchased by Richard Buckley and Gonzalo Sanchez from Manhattan. The house lies off Route 9W on a 6-acre piece of open land. The front stoop of this two-story frame house overlooks Storm King Mountain, and a large tidal estuary of the Hudson River, that is now a migratory bird sanctuary, owned by Scenic Hudson.

From the Van Hoesen House

From Holland.....

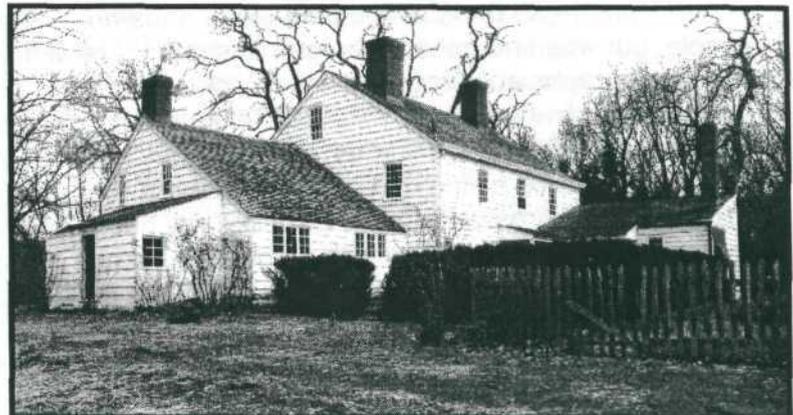
Back of The Squire Nicoll House

The original Nicoll House is thought to have been built in the 1730's and there is evidence of this in the design of a surviving molded hand-rail in the cellar. Most of the house reflects its final major change in the late 18th century. The main house began as two-story one-room deep house that was later widened one-room. The evidence of this is in the loft, and in the changes that were necessary to the rafters. The two-large chimneys were constructed in this second phase. The original frame is a traditional English scribe-rule box-frame with flared posts. These posts project into the corners of many of the rooms, a characteristic of English flared post construction. The rafters are joined with bird's mouths to the wall-plate.

Little of the two frames are exposed but in the loft the floor on the addition side is about 8-inches lower than the older front half, indicating local carpenters had abandoned the English box-frame for a Dutch frame with a short half-story knee-wall.
