**Saturday July 8** A bunch of HVVA members manned a long table with books, pamphlets and object of curiosity aside Bob Eurich's stone house on the crowded main street of the Village of Hurley (Nieuw Dopf), the second Dutch settlement in Ulster County and important in its early history. Throughout the day we met lots of old friends and historic home owners, sold a good quantity of books and acquired some new members. Hurley Stone House Day is a well attended annual event, 2<sup>nd</sup> Saturday in July, just a couple of miles from the Bievier House Museum where some HVVA members are working.

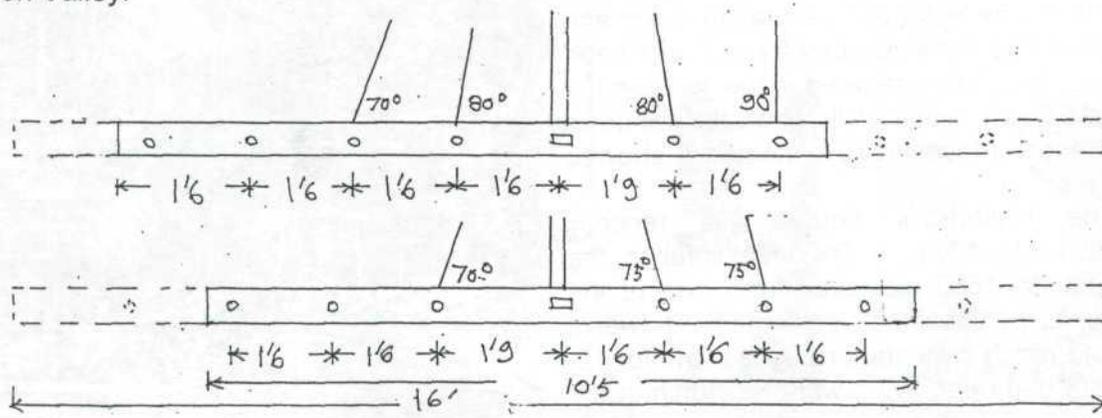
**Two 10'5" Long Fragments of Barrack Plates Reused in  
The Salsman Farm Dutch Barn, Rhinebeck, Dutchess Co., NY (Rhi-27)**

These plates show that 16-foot barracks sometimes had 8 minor rafters per side.

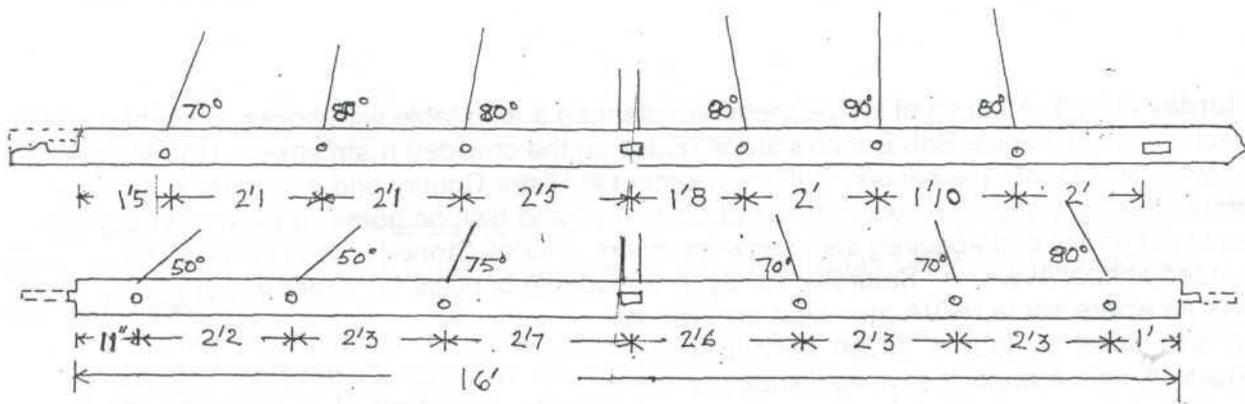
#### Two Complete Barrack Plates Used as Mow-Poles in The Dressel Farm Dutch Barn, New Paltz, Ulster Co., NY (NP-7)

These plates have the more usual 6-minor rafters per side. They are the only examples known to retain evidence of their through mortise and tenon joining. These examples show a great variety in the spacing of rafter holes.

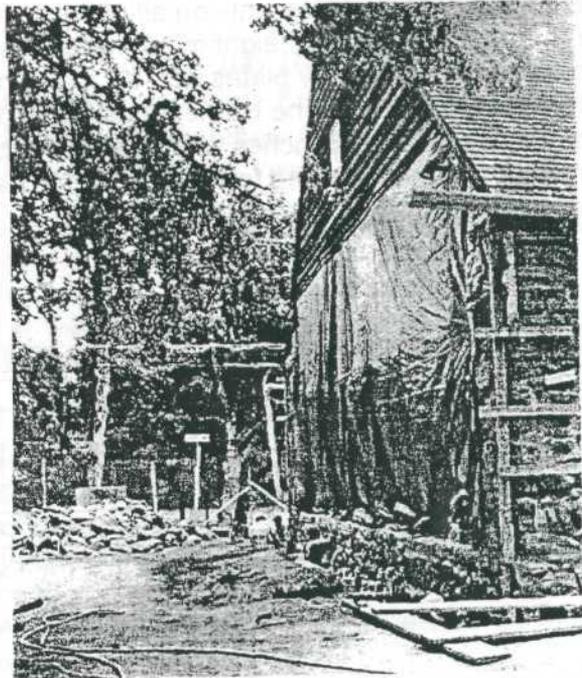
#### The Jean Hasbrouck House, 1721 New Paltz, Ulster County, NY

Behind a protective tarp, the story-and-a-half stone wall has been removed, each stone identified to be replaced in its original position. The 2-foot thick field-stone wall had failed because of years of water damage.
